# Mitigating Post-Fire Runoff from the Schultz Fire

# ASCE/ASHE 2015 Annual State Conference

SCHULTZ COMMUNITY RECOVERY

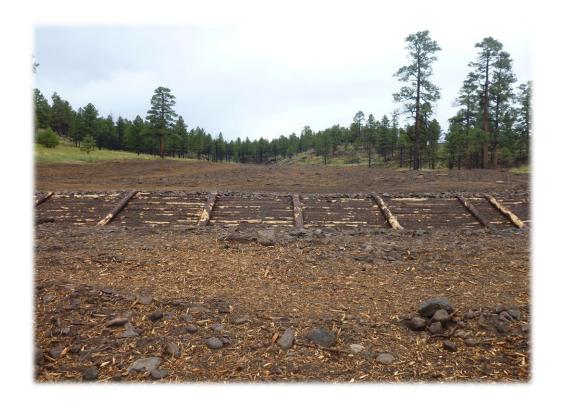
Restored Alluvial Fan in the Lennox Watershed – Wupatki Trails Project

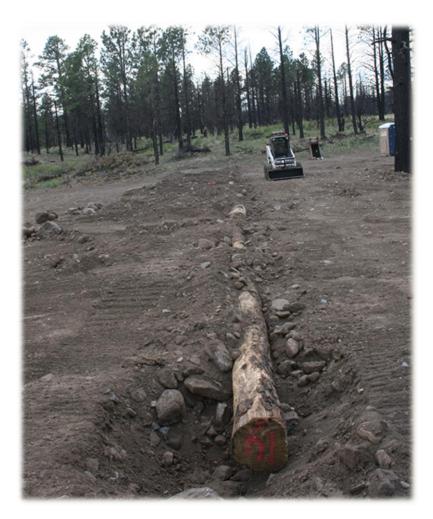
Log Sills across the fans prevent head-cutting and keep the flows spread out

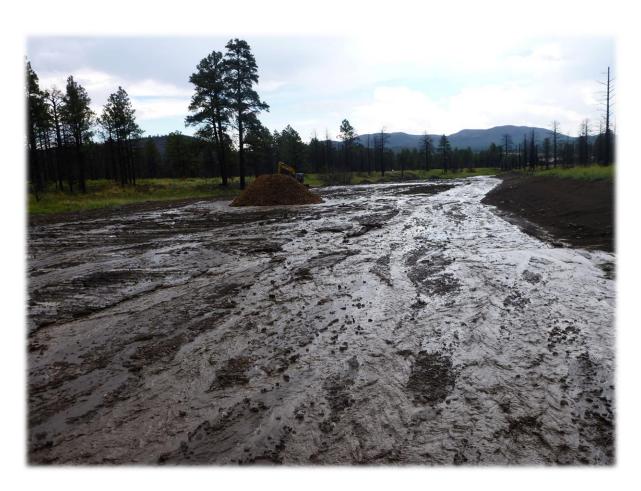
Restored Alluvial Fan in the Thames Watershed – Brandis Project

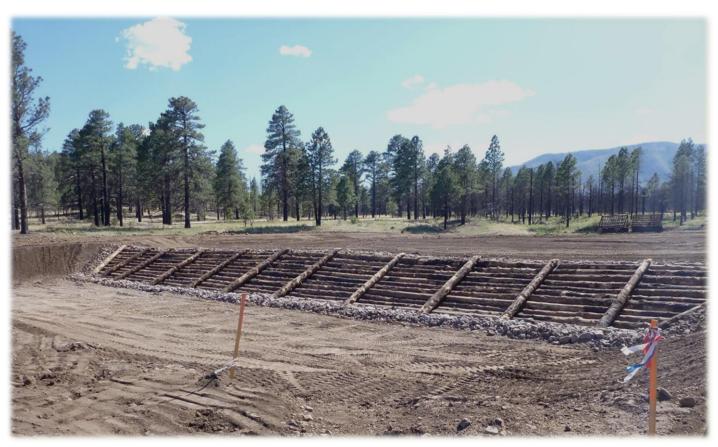
Design storm runoff collects in the Terminal Trench at the end of the last fan and flows out through the Transition Channel into the neighborhood improvements

Terminal Trench – Constructed with Forest materials

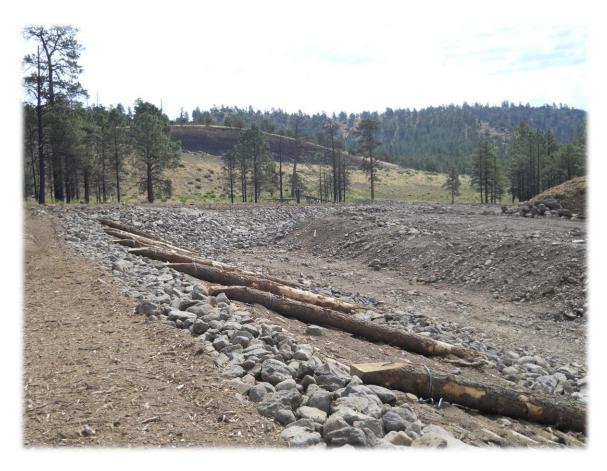
Transition Channel exiting the Terminal Trench

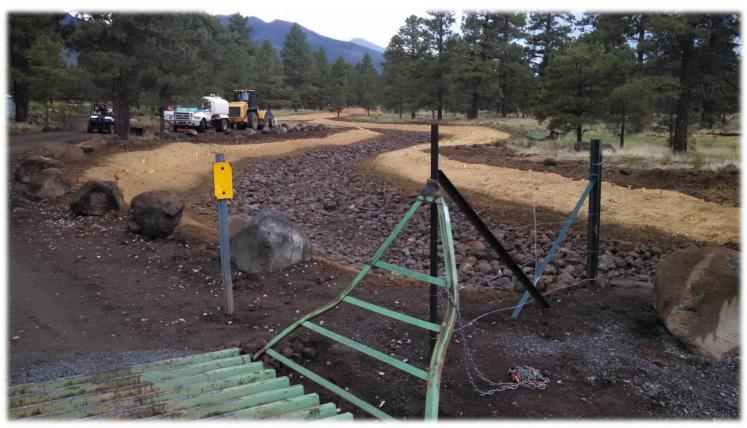
Transition Channel through the forest entering the neighborhood

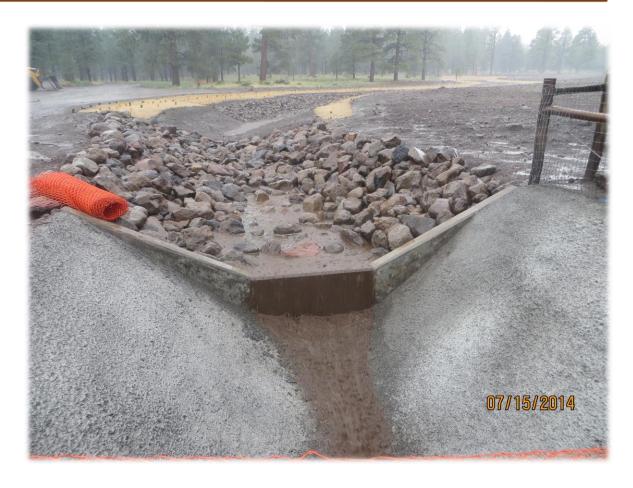
Transition Channel joining the neighborhood improvements

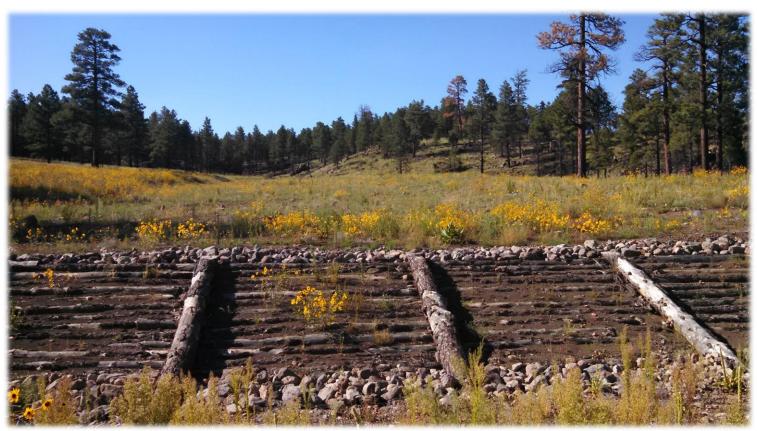
Lennox-Wupatki Alluvial Fan and Terminal Trench ~ 1 Year after construction

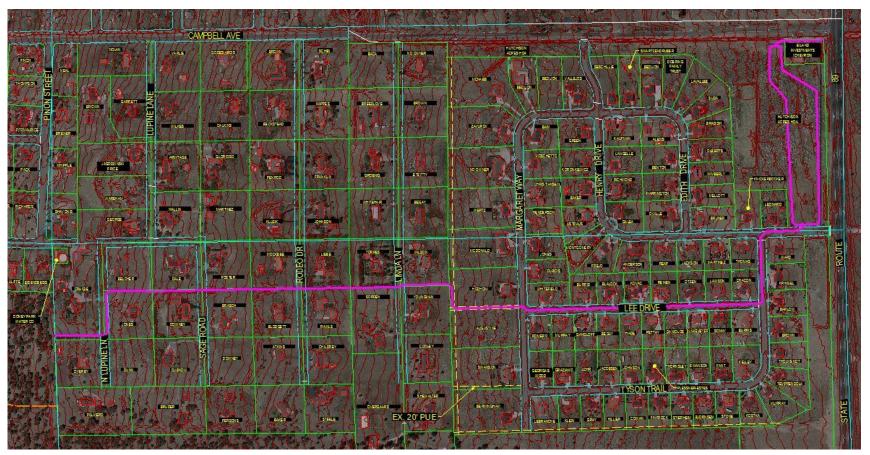
Typical Neighborhood Improvement Alignment - South Paintbrush

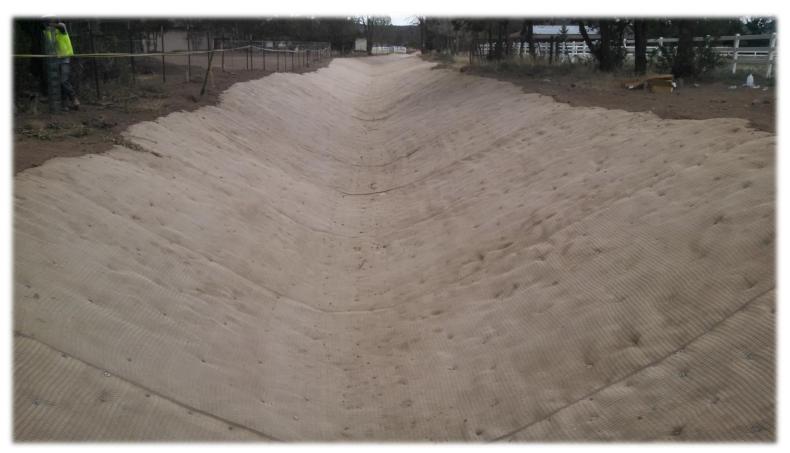
Typical Neighborhood Improvement – Turf Reinforcement Mat (TRM) Channel

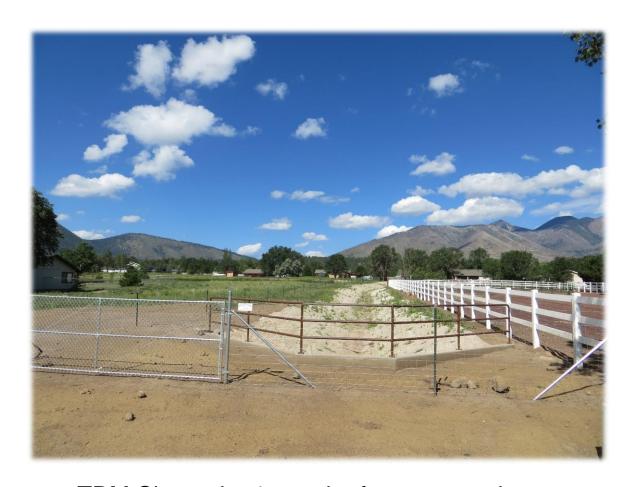
TRM Channel ~ 1 month after construction

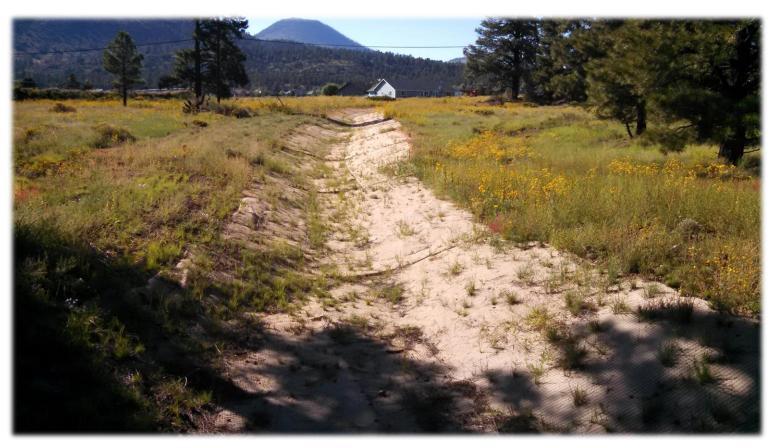
TRM Channel ~ 1 year after construction

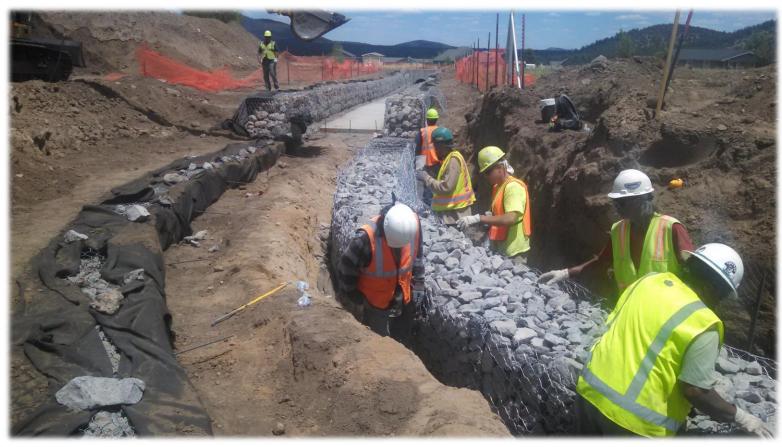
Typical Neighborhood Improvement - Gabion Channel with a Concrete Bottom

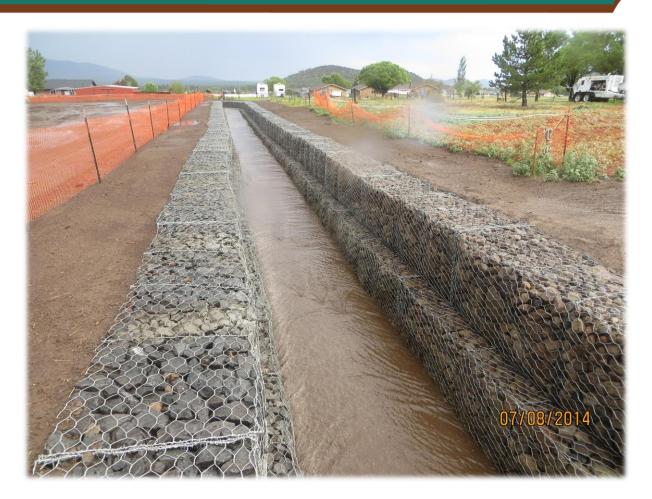
Typical Neighborhood Improvement - Gabion Channel with a Concrete Bottom

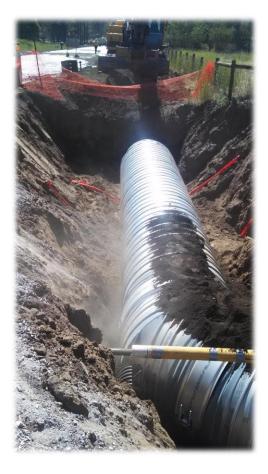
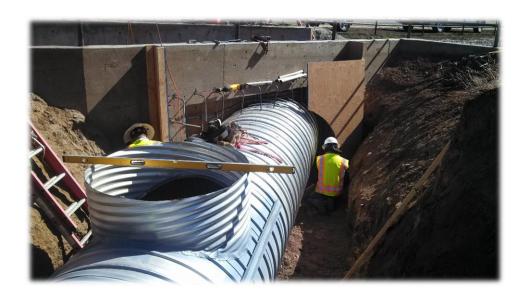
Typical Neighborhood Improvement – Storm Drain

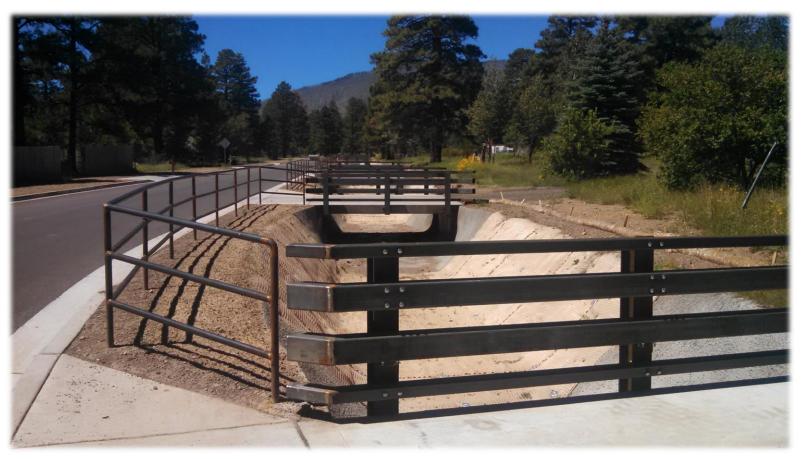
Typical Neighborhood Improvement – Driveway Box Culverts and TRM Channel

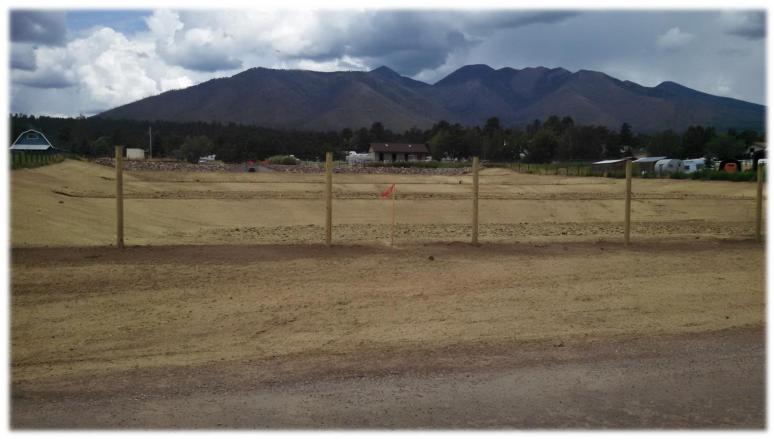
Typical Neighborhood Improvement – Detention

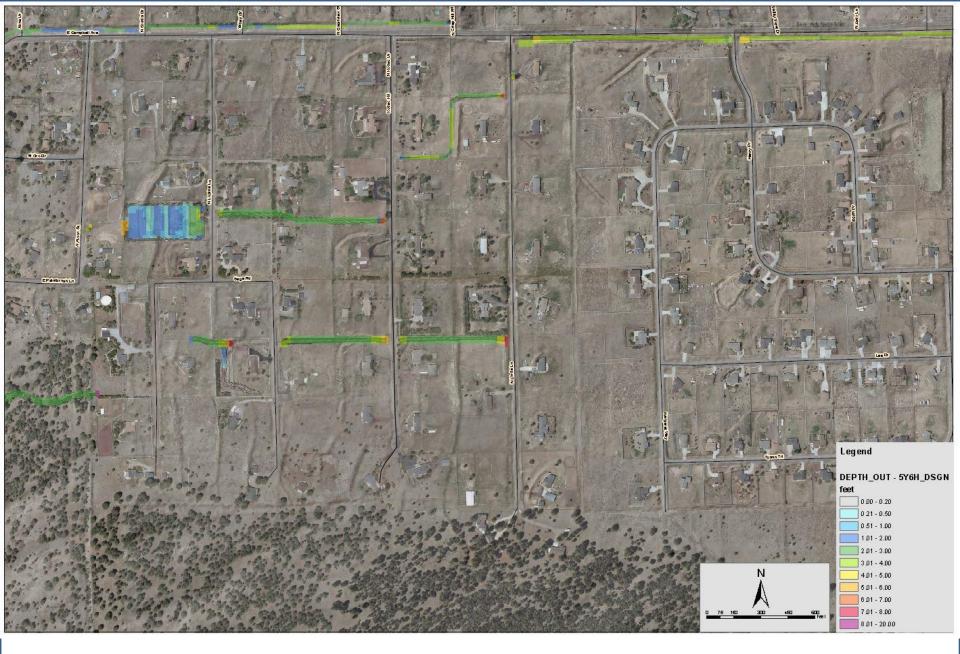
5 yr./6 hr. Storm - Prop. Condition - Mid

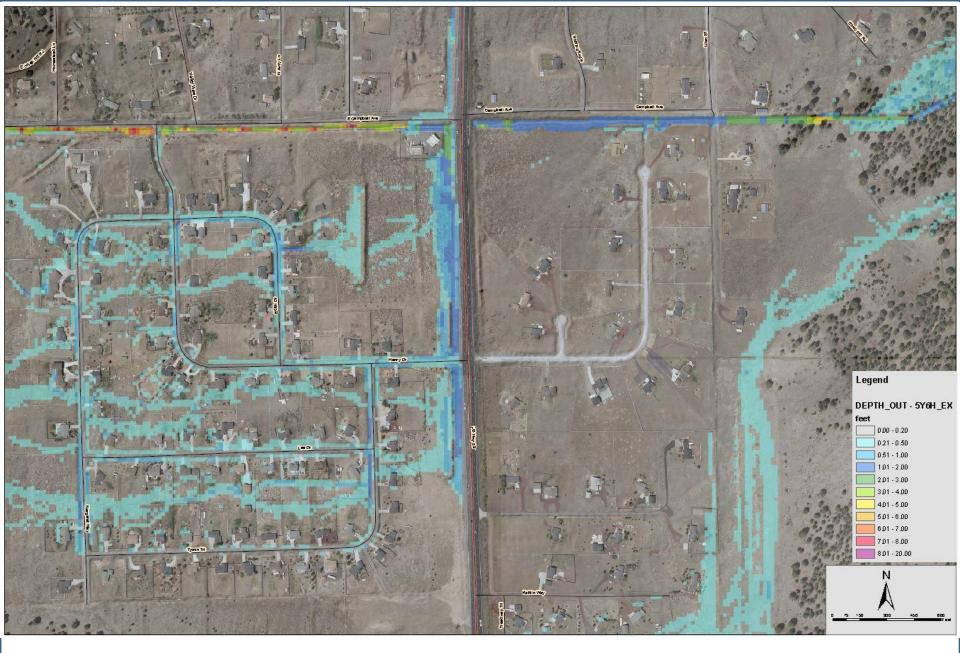
5 yr./6 hr. Storm - Ex. Condition - East

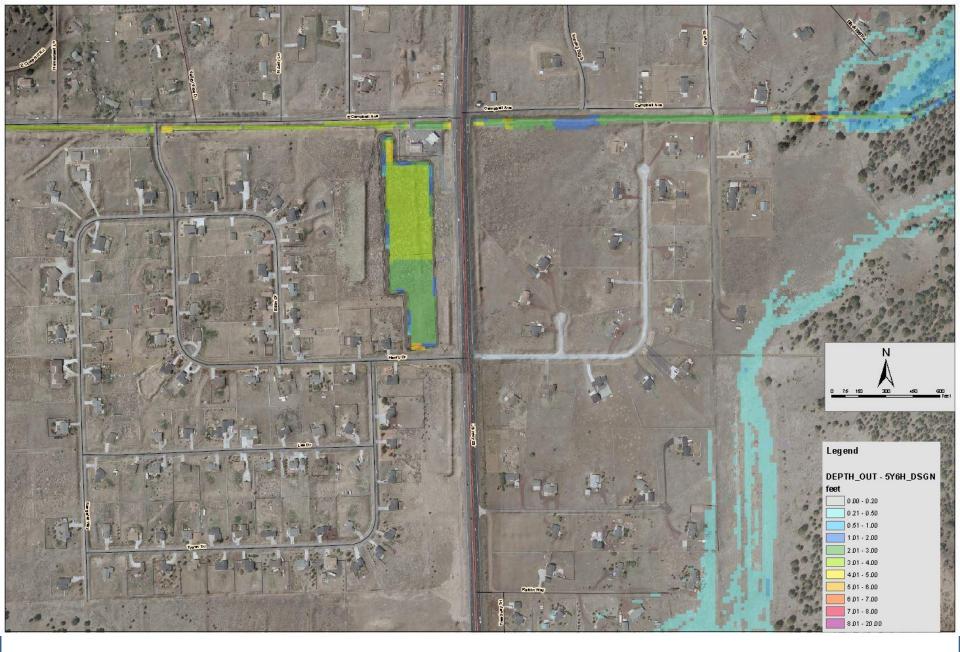
5 yr./6 hr. Storm - Prop. Condition - East

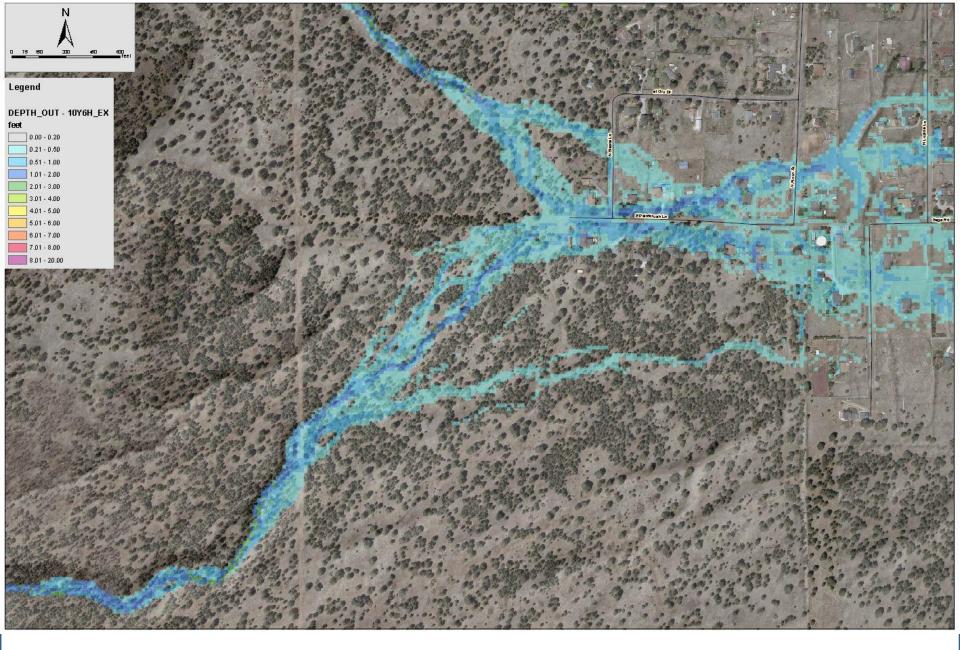
10 yr./6 hr. Storm – Ex. Condition - West

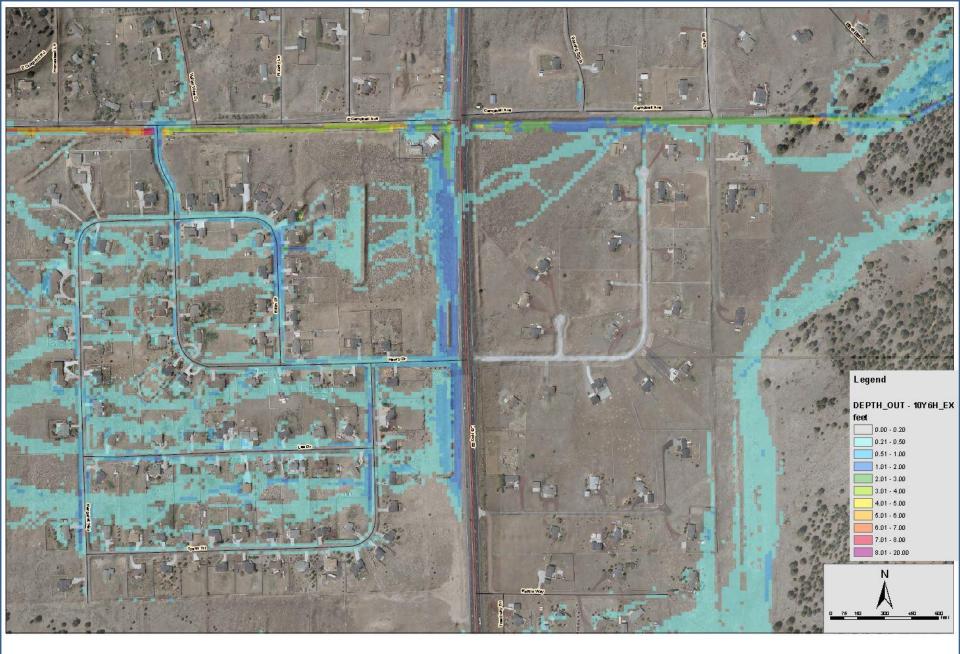
10 yr./6 hr. Storm - Ex. Condition - East
