2016 ANNUAL ASCE / ASHE STATE CONFERENCE

The High & Low of Engineering Options

Jerry A. Cannon, P.E., S.E.
Bridge Engineer

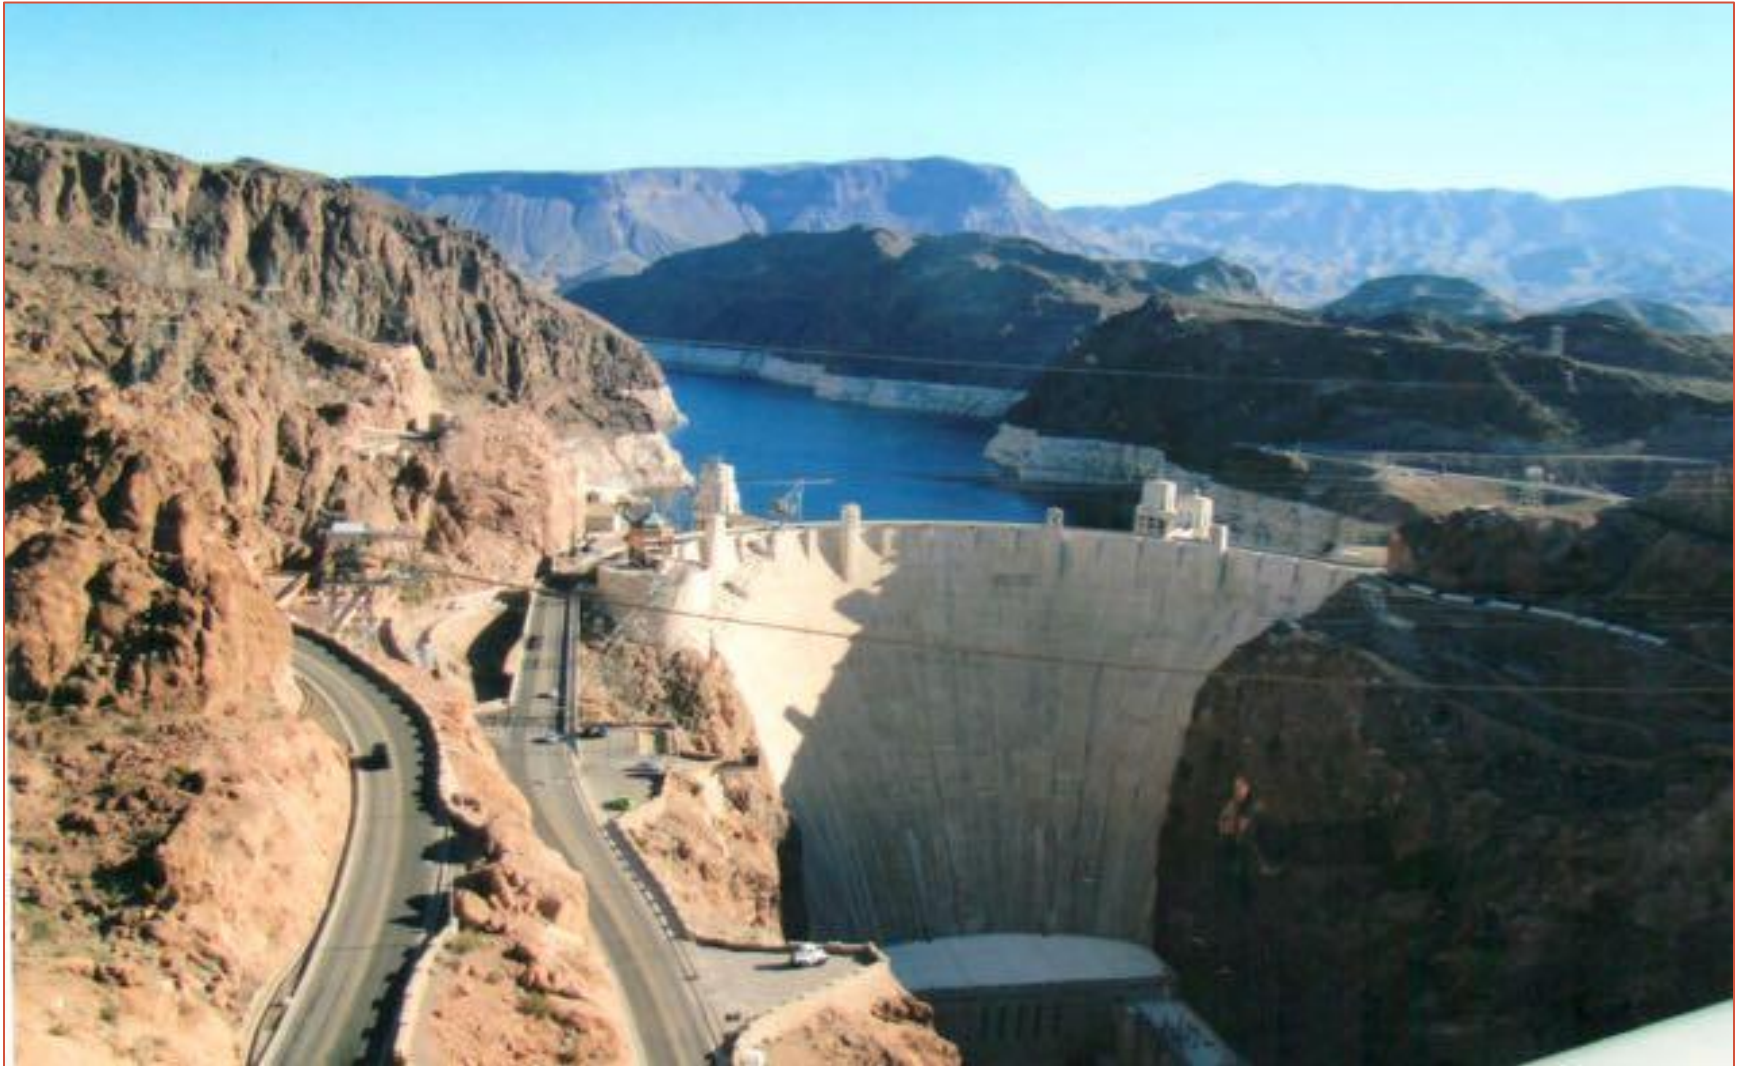
Hoover Dam

Low barrier rail and decorative design
using concrete

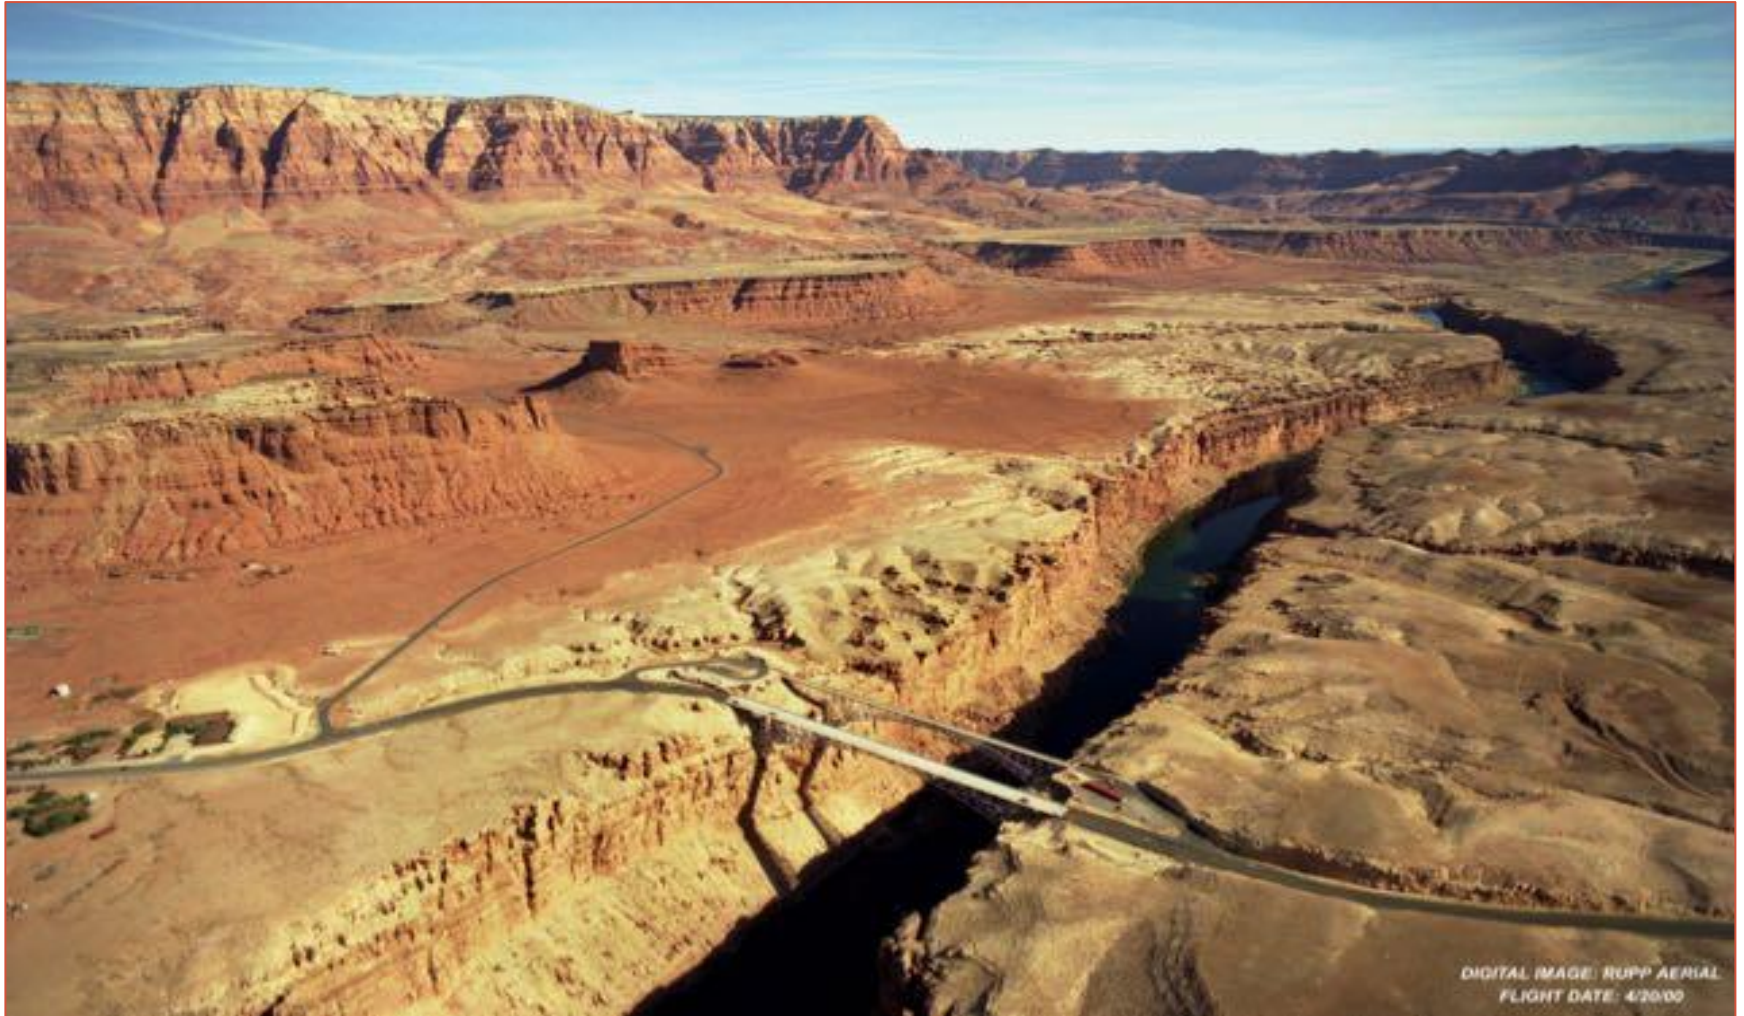
Navajo Bridges over Colorado River

New Navajo Bridge with Interpretive Center / Navajo commercial between two closely spaced bridges “a perfect fit”.

- ❖ Example of context sensitive design
- ❖ New bridge located to fit into site rather than by the roadway alignment
- ❖ Compatible appearance
- ❖ Spectacular view of canyon not blocked by new bridge
- ❖ Closely spaced parallel bridges reduce visual confusion

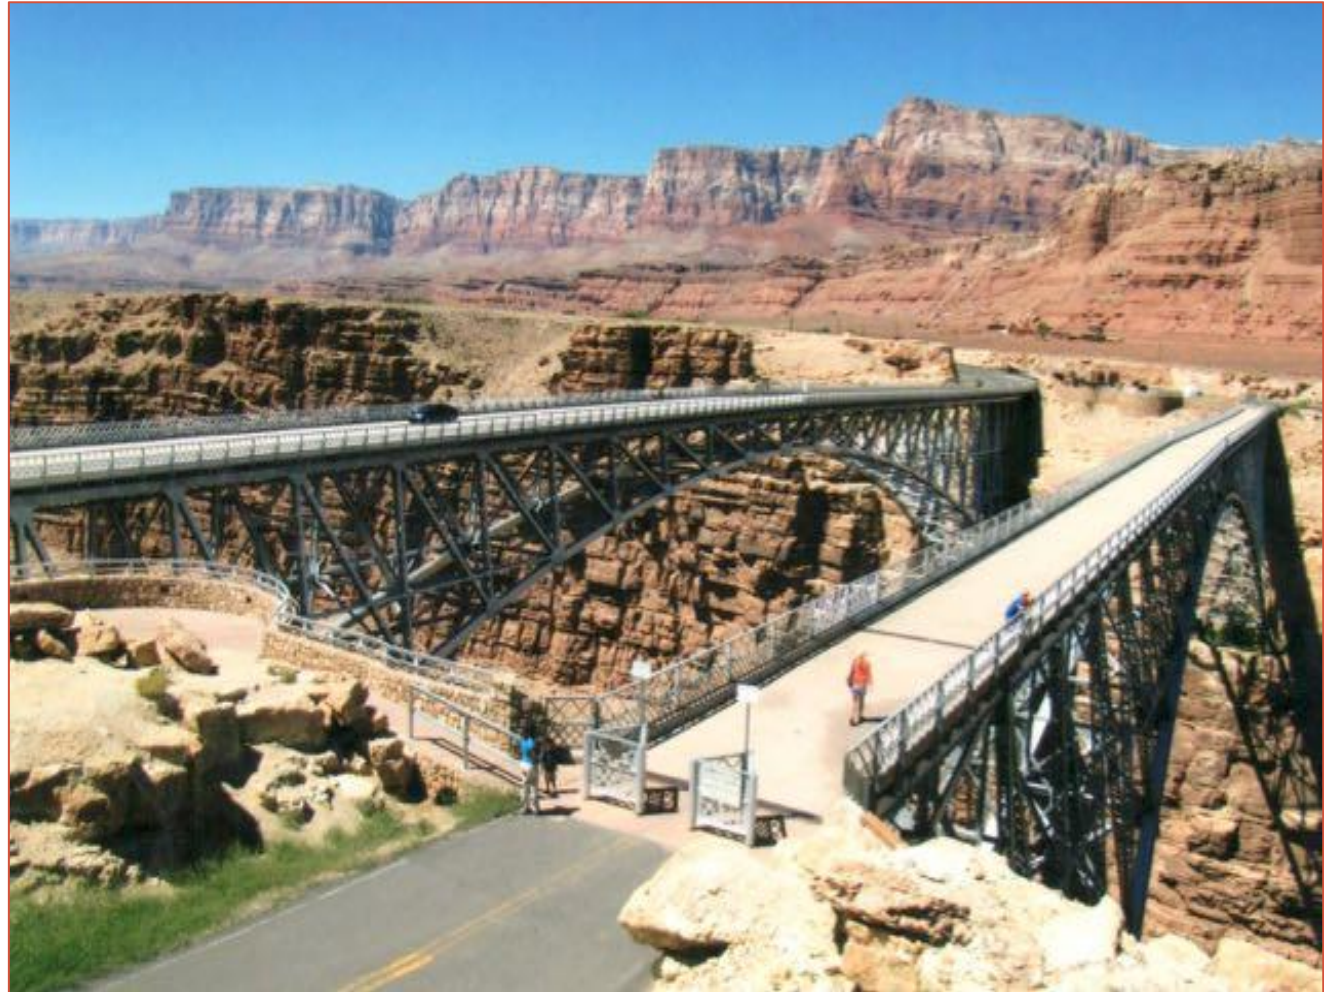
US93 Kaiser Spring Bridges

New piers located between canyons with spans over 200 feet.

- ❖ Curved box girder fits nicely with curved roadway
- ❖ This engineering option was selected rather than using AASHTO I-girders
- ❖ Bridge length fits into landscape at site
- ❖ Integrated art is sustainable

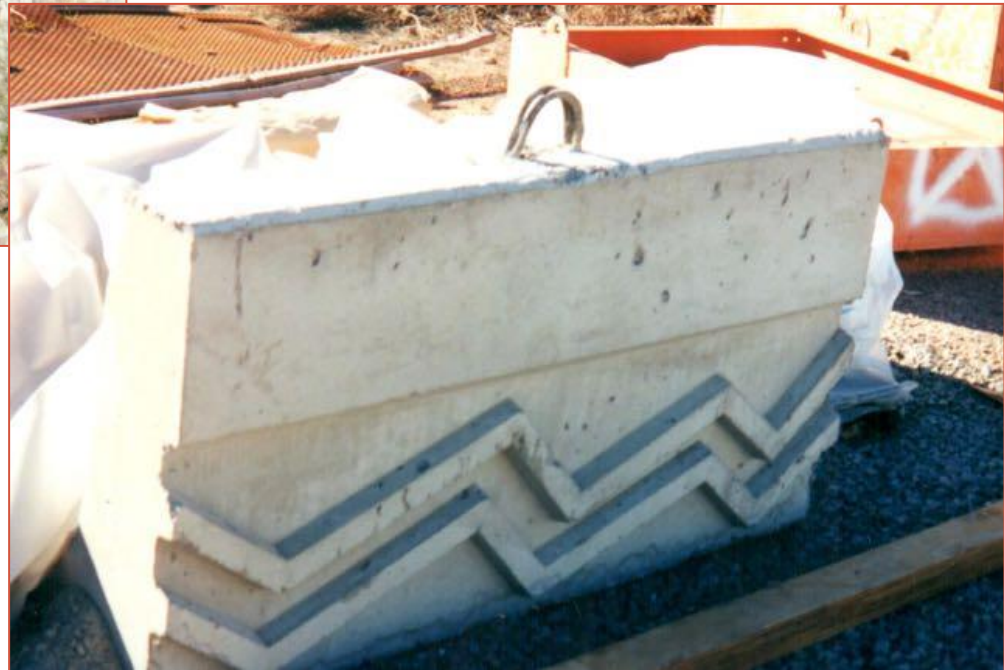
US93 Kaiser Spring Bridges

Cast-in-place
prestressed concrete
box girders on falsework

Bridge barrier wall
treatment

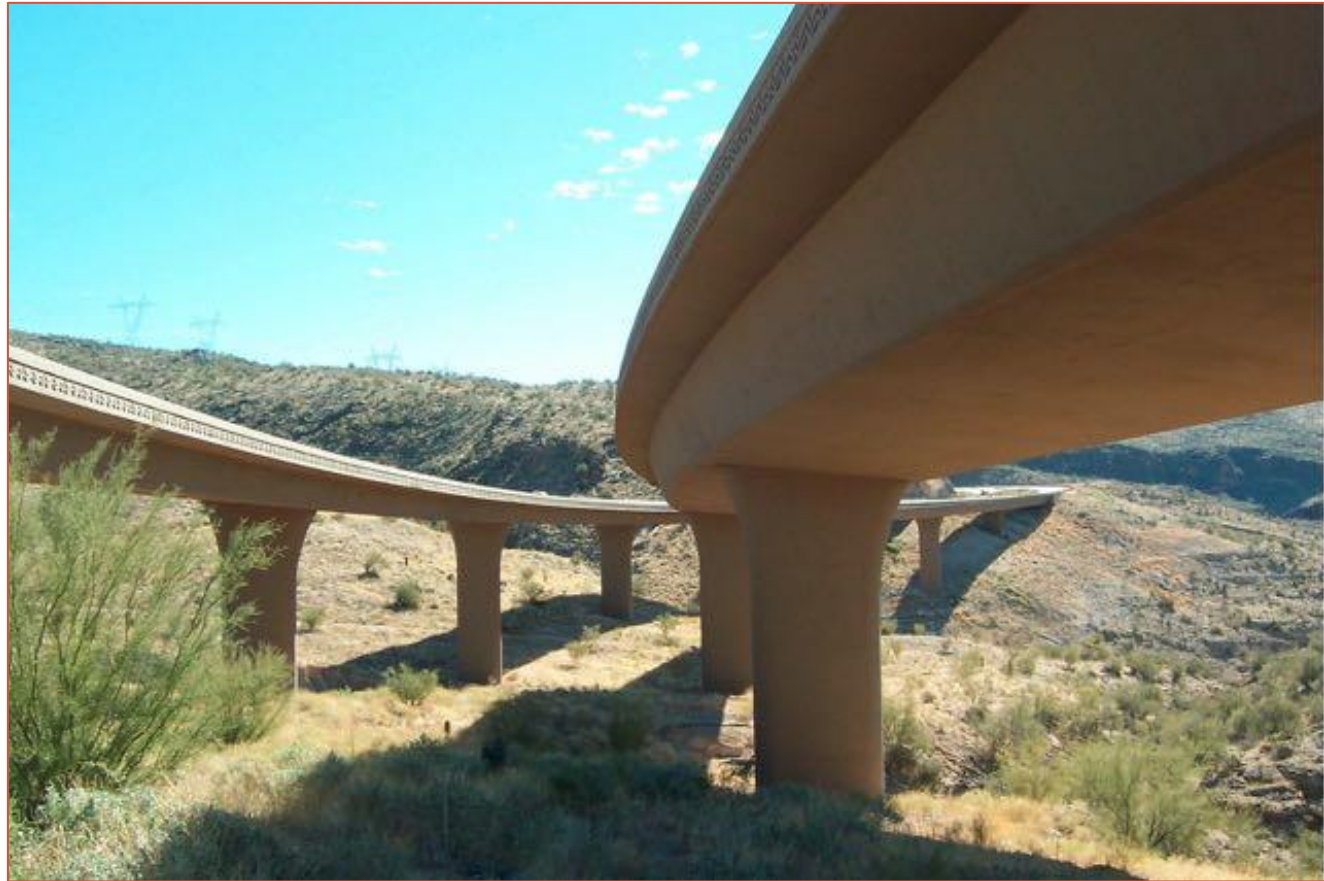
Bridge Traffic Interchange Structure Types

Shorter span AASHTO I-girders require straddle bents which cause visual confusion.

- ❖ Designers need to creatively use basic bridge elements rather than attaching applied art
- ❖ Cast-in-place box girders allow for longer spans which reduce clutter and visual confusion.
- ❖ The *least* structure is the best one.

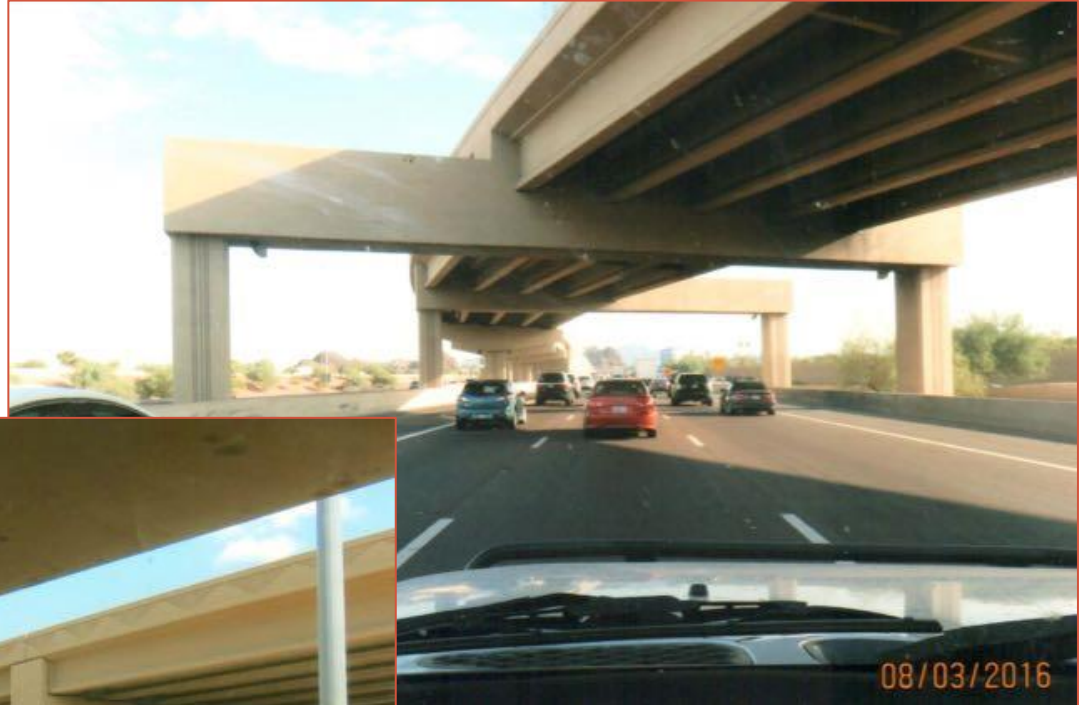
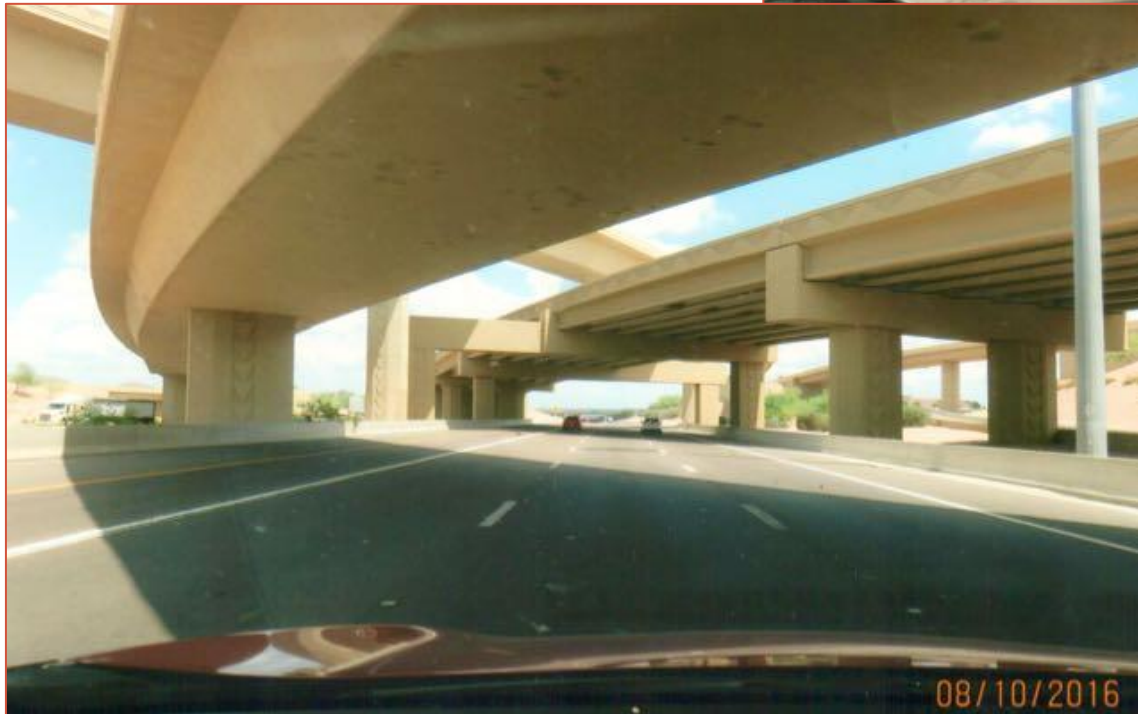
Cast-in-place box girder with longer spans reduce visual confusion.

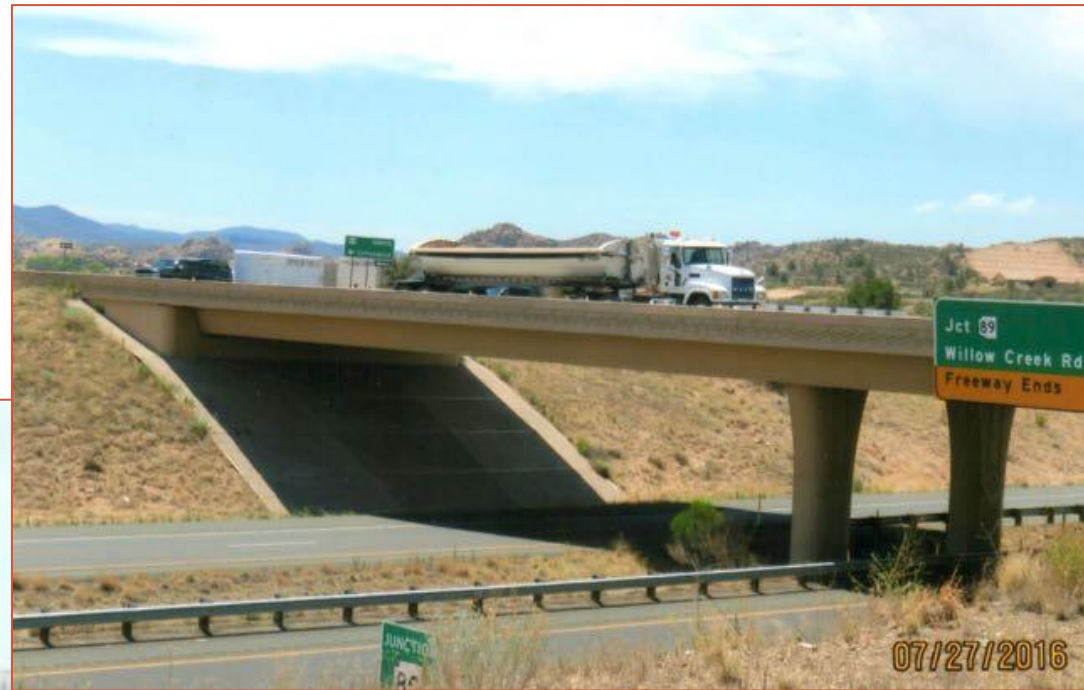
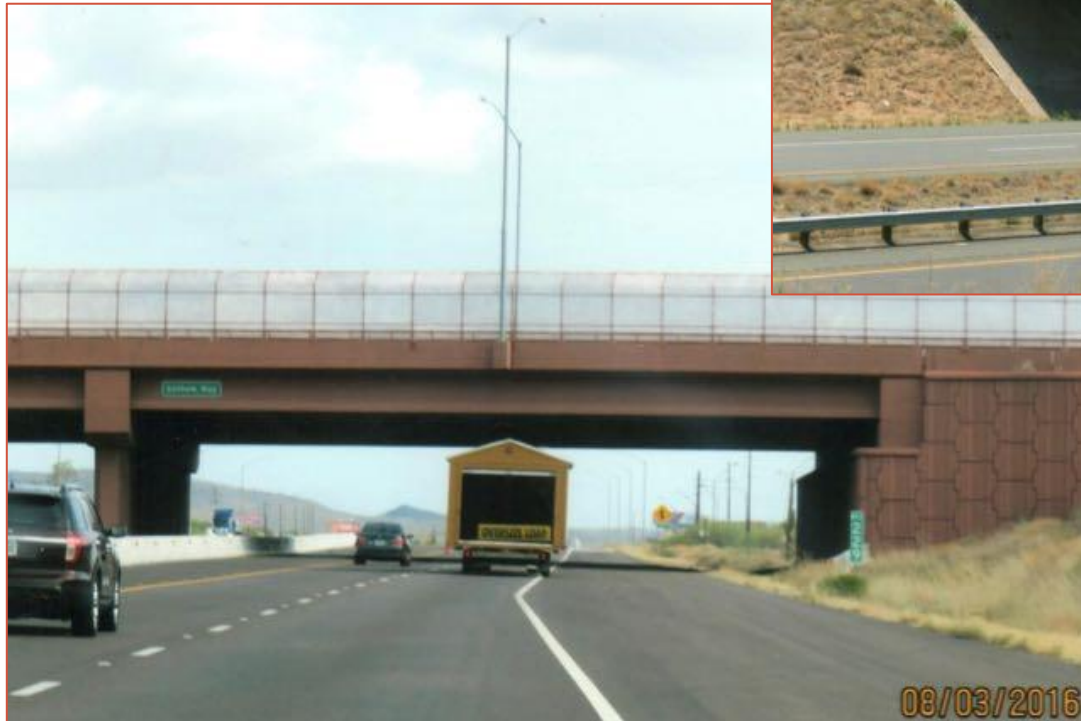
Bridge Traffic Interchange Abutment Options

Abutments blend into roadway embankment and provide a more open feeling.

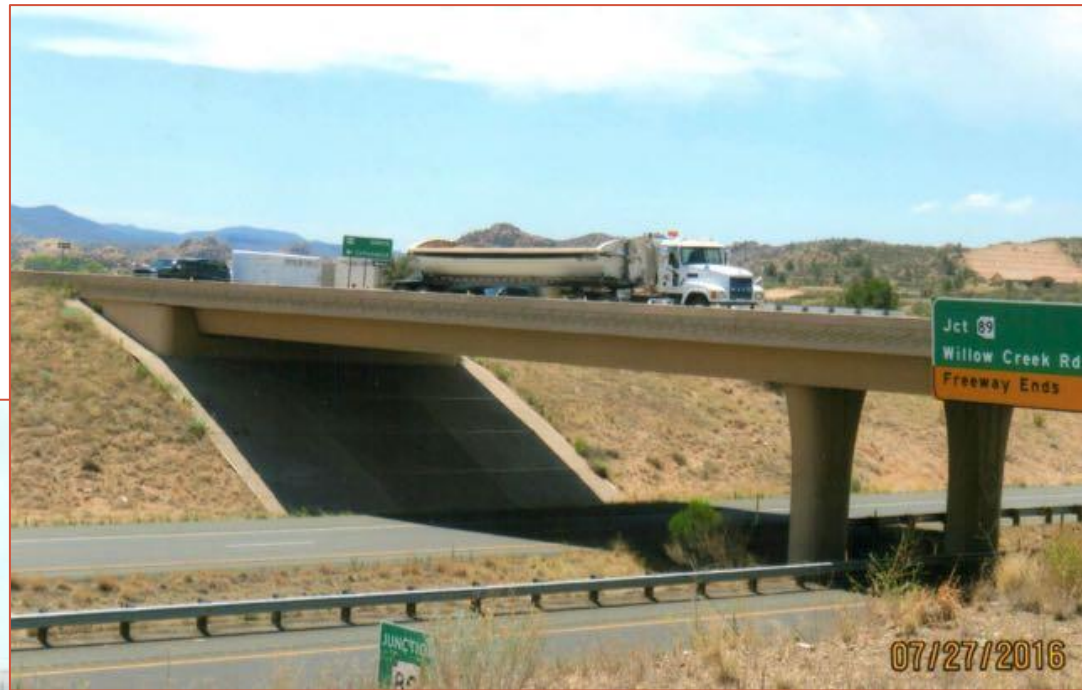
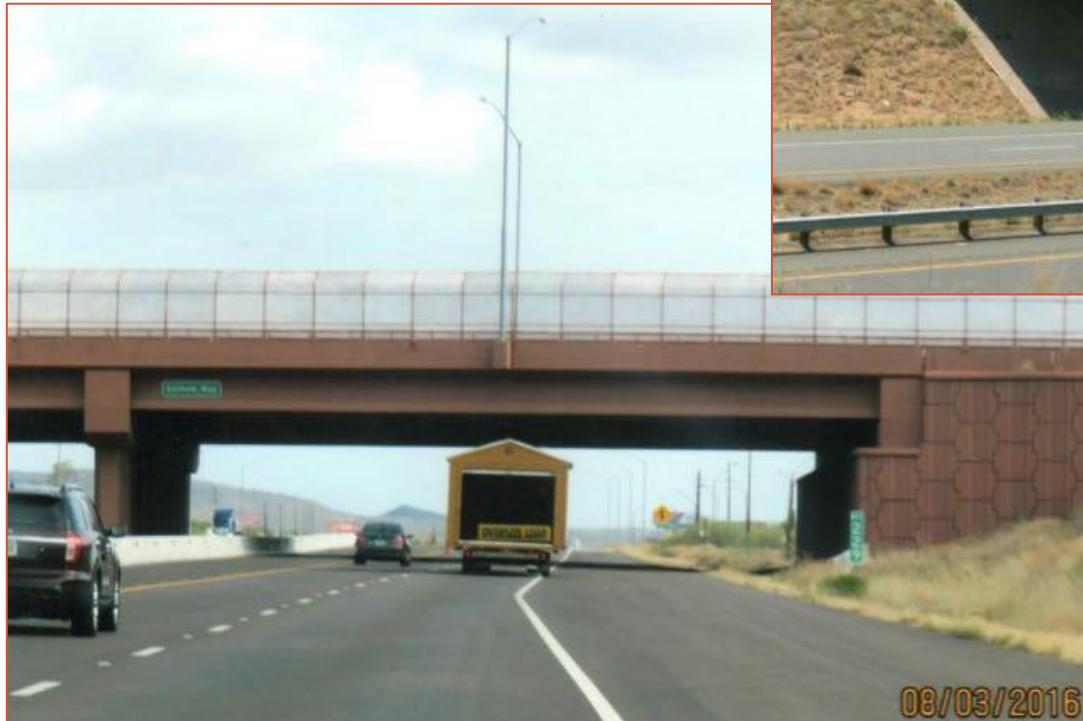
Full height abutment walls tend to narrow opening and become an impediment to traffic flow.

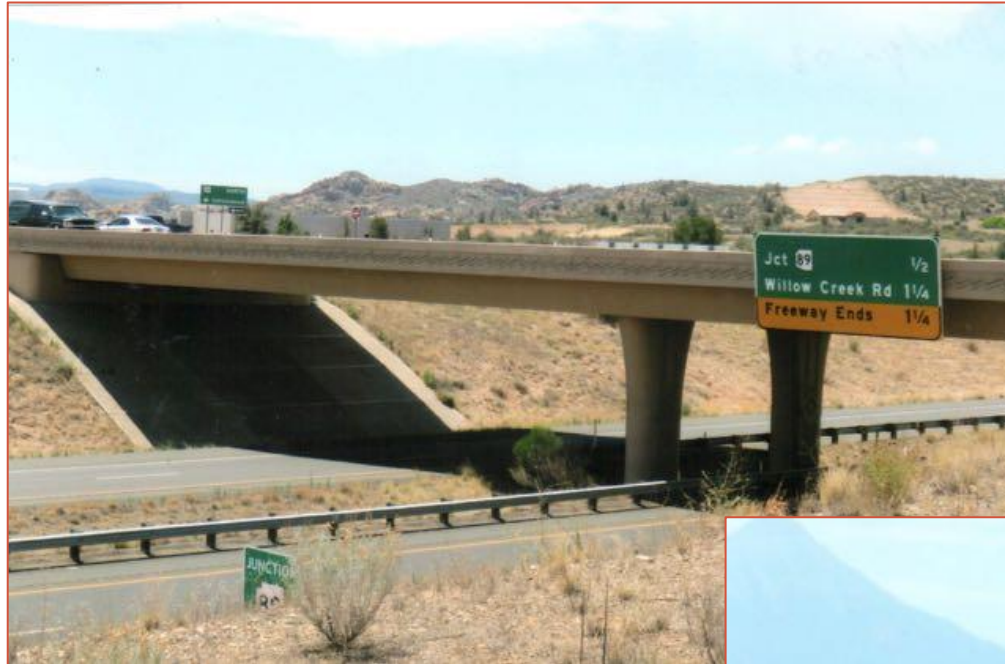
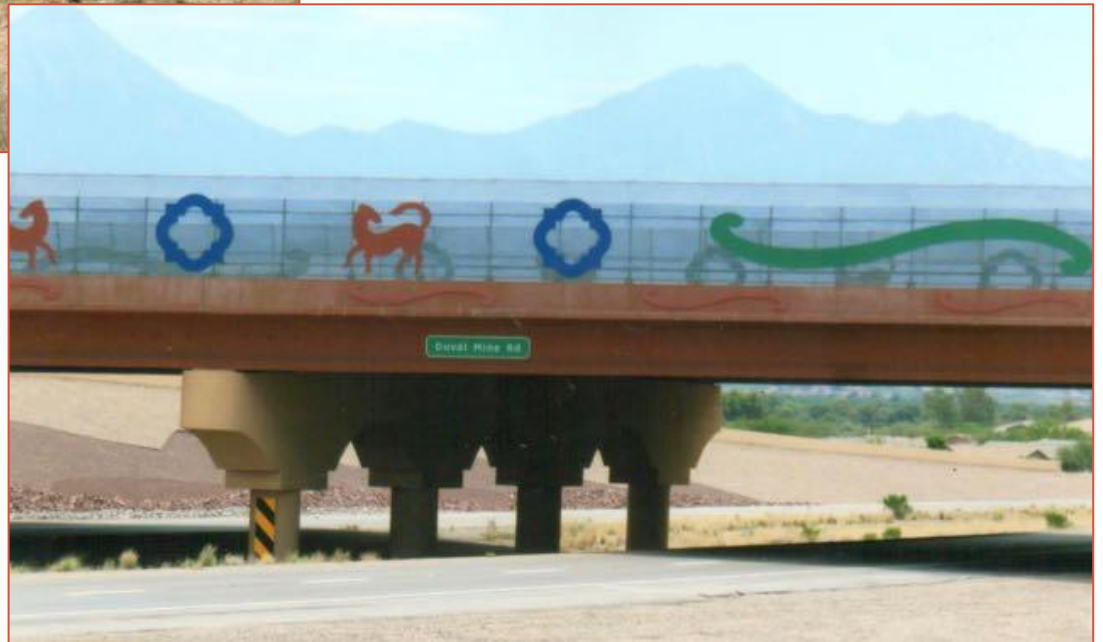
Bridge Traffic Interchange Pier Option

Tapered pier columns provide a simple and attractive appearance.

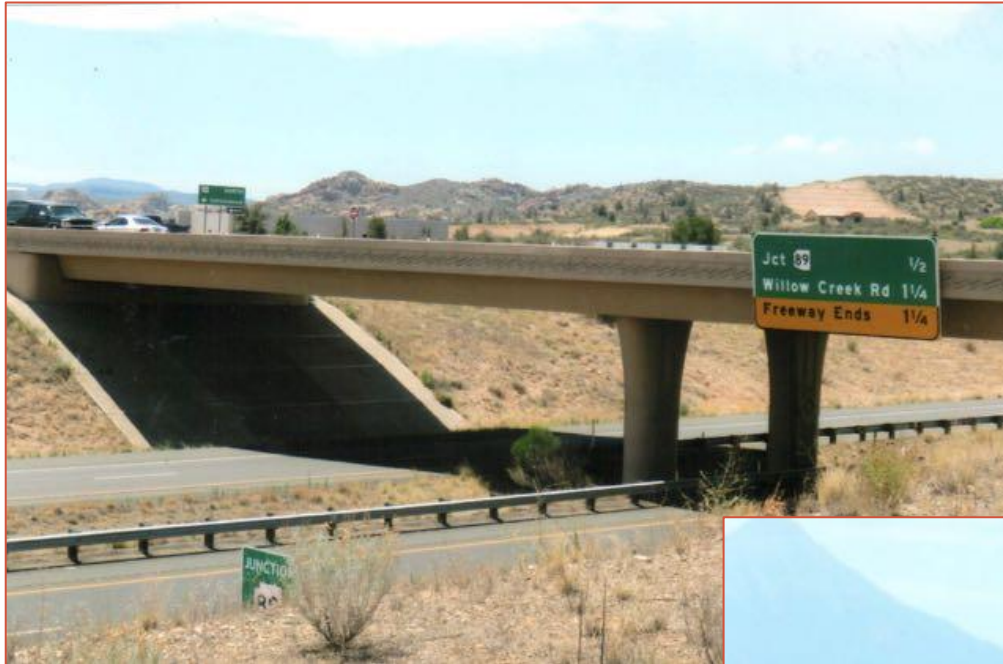
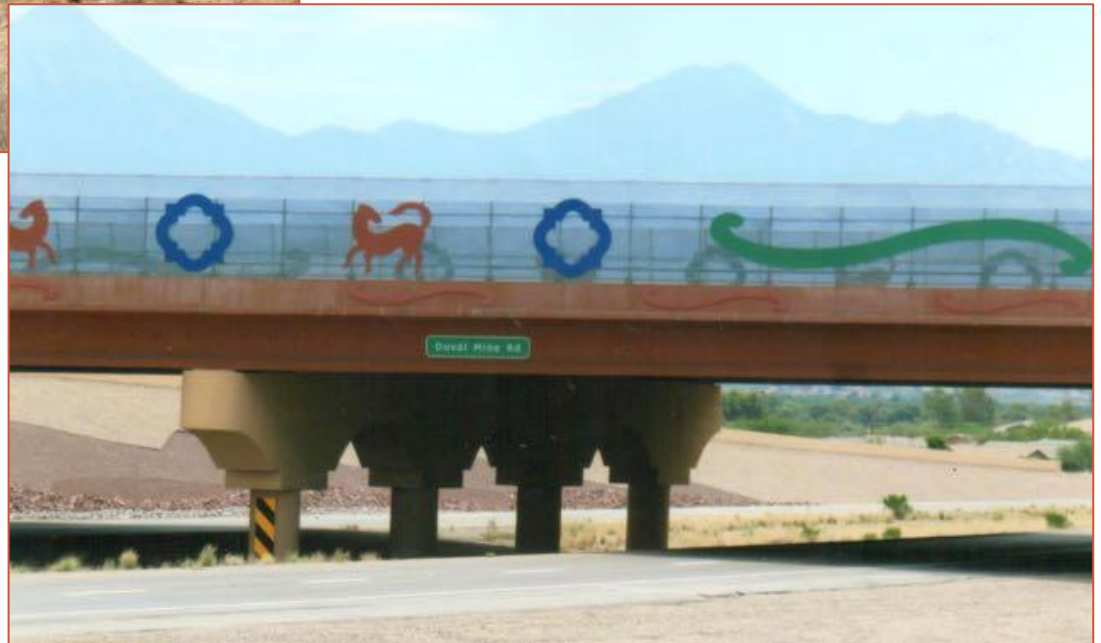
Unusual design of pier columns. Applied artwork doesn't always improve appearance – it just adds confusion and reduces sustainability.

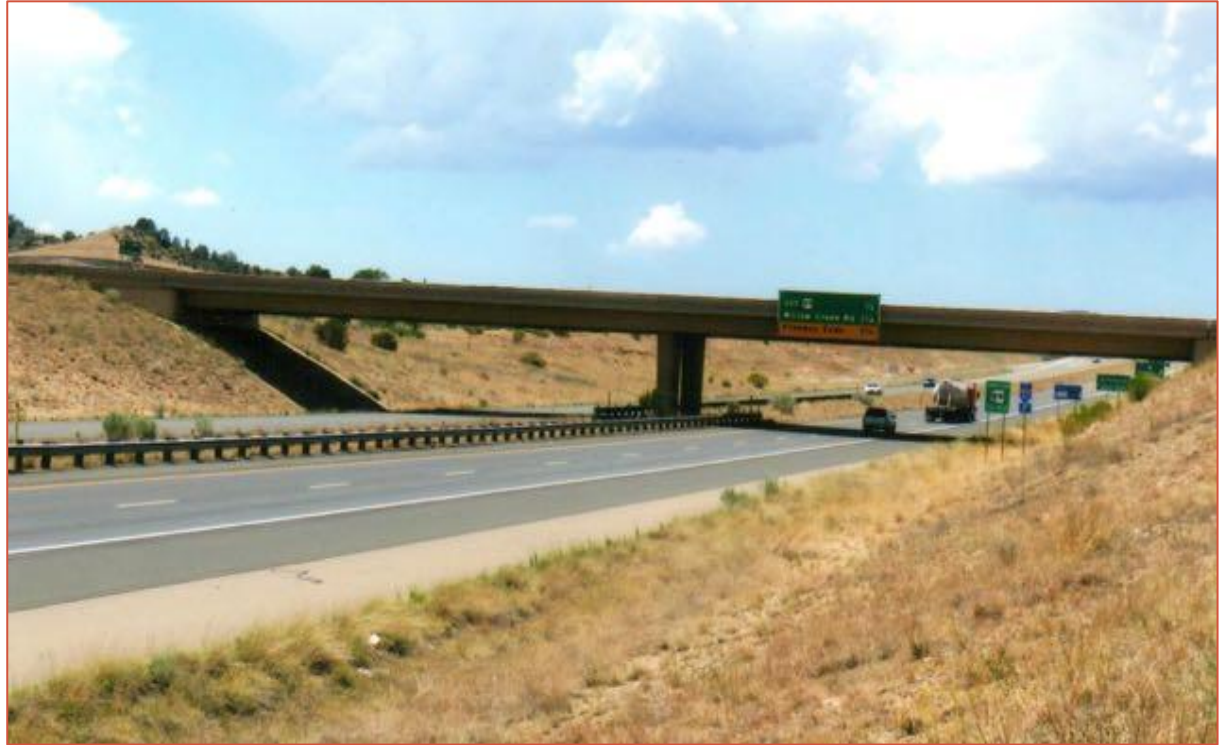
Bridge Traffic Interchange Options

Cast-in-place prestressed box girder with short abutment walls – fits well into the landscape.

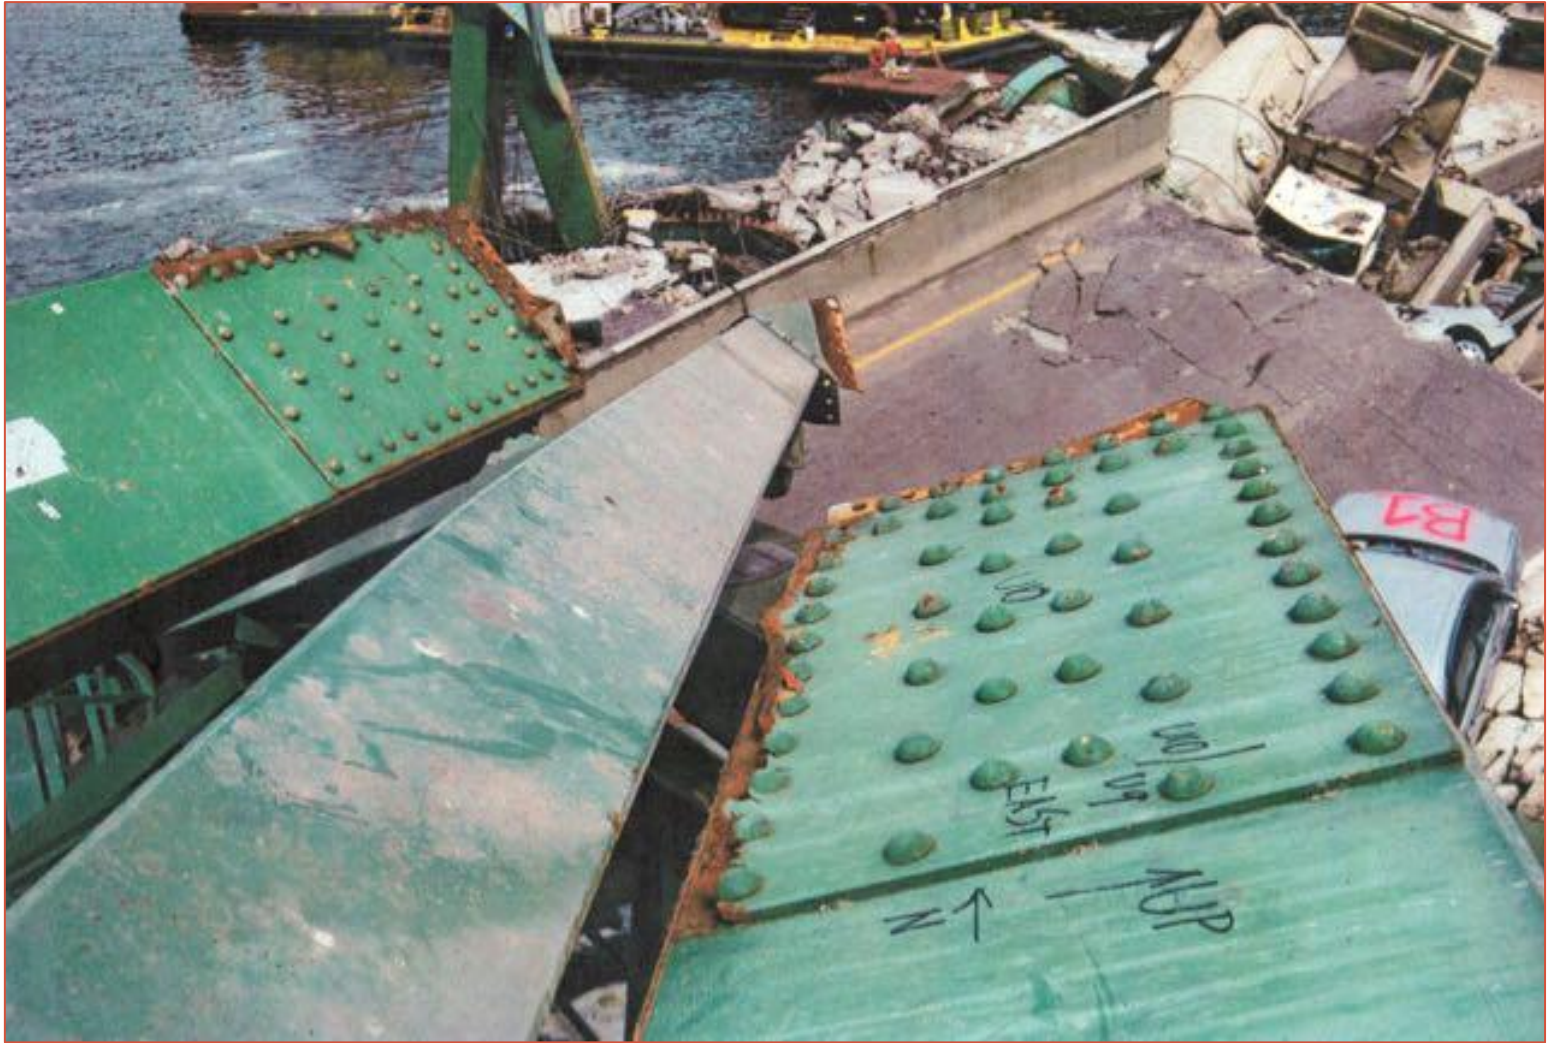
I-35W over Mississippi River

Gusset
Plate
Failure

- ❖ Gusset plates were too thin
- ❖ Fracture critical bridge

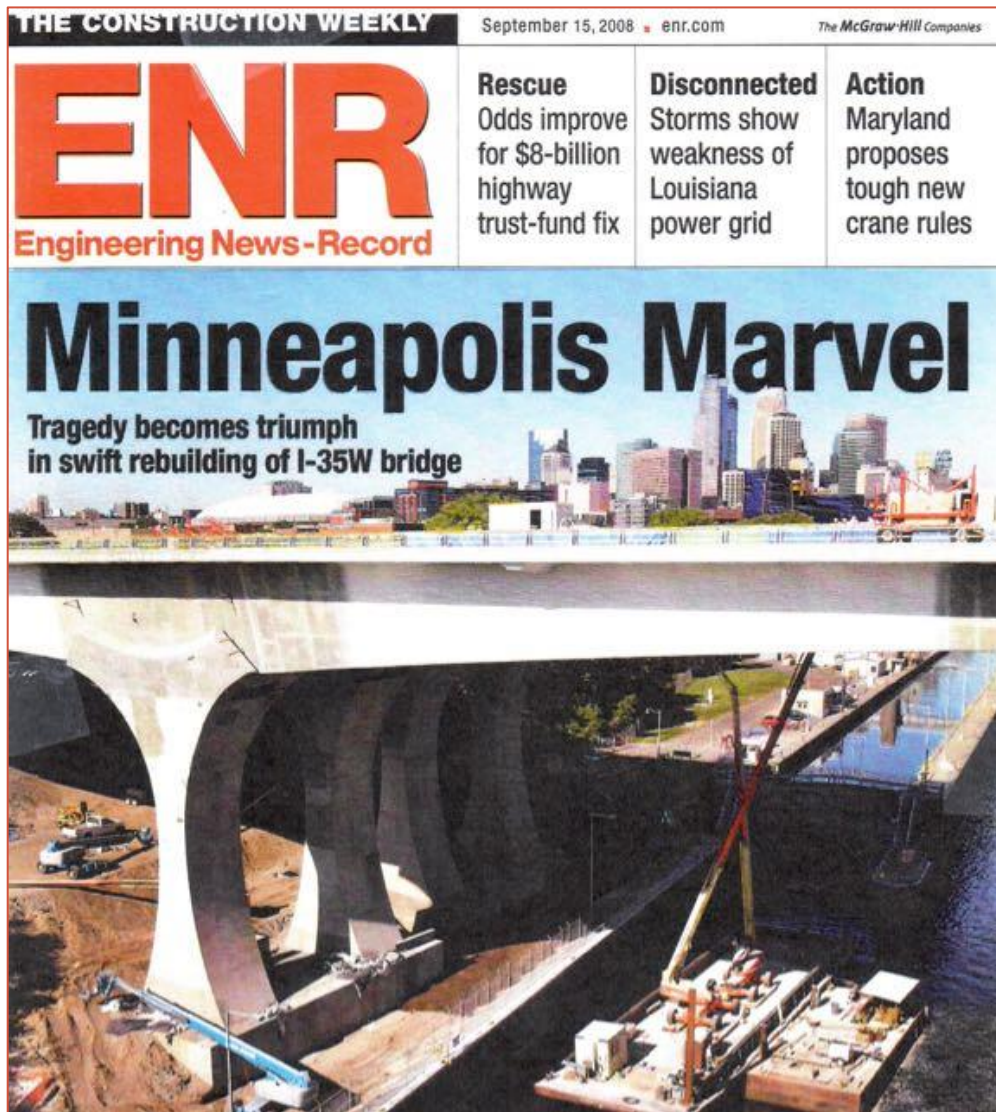
I-35W over Mississippi River (2008)

- ❖ Replacement bridge design by Figg Engineering using segmental concrete design
- ❖ Innovative design that was both cost effective and provided an attractive bridge.

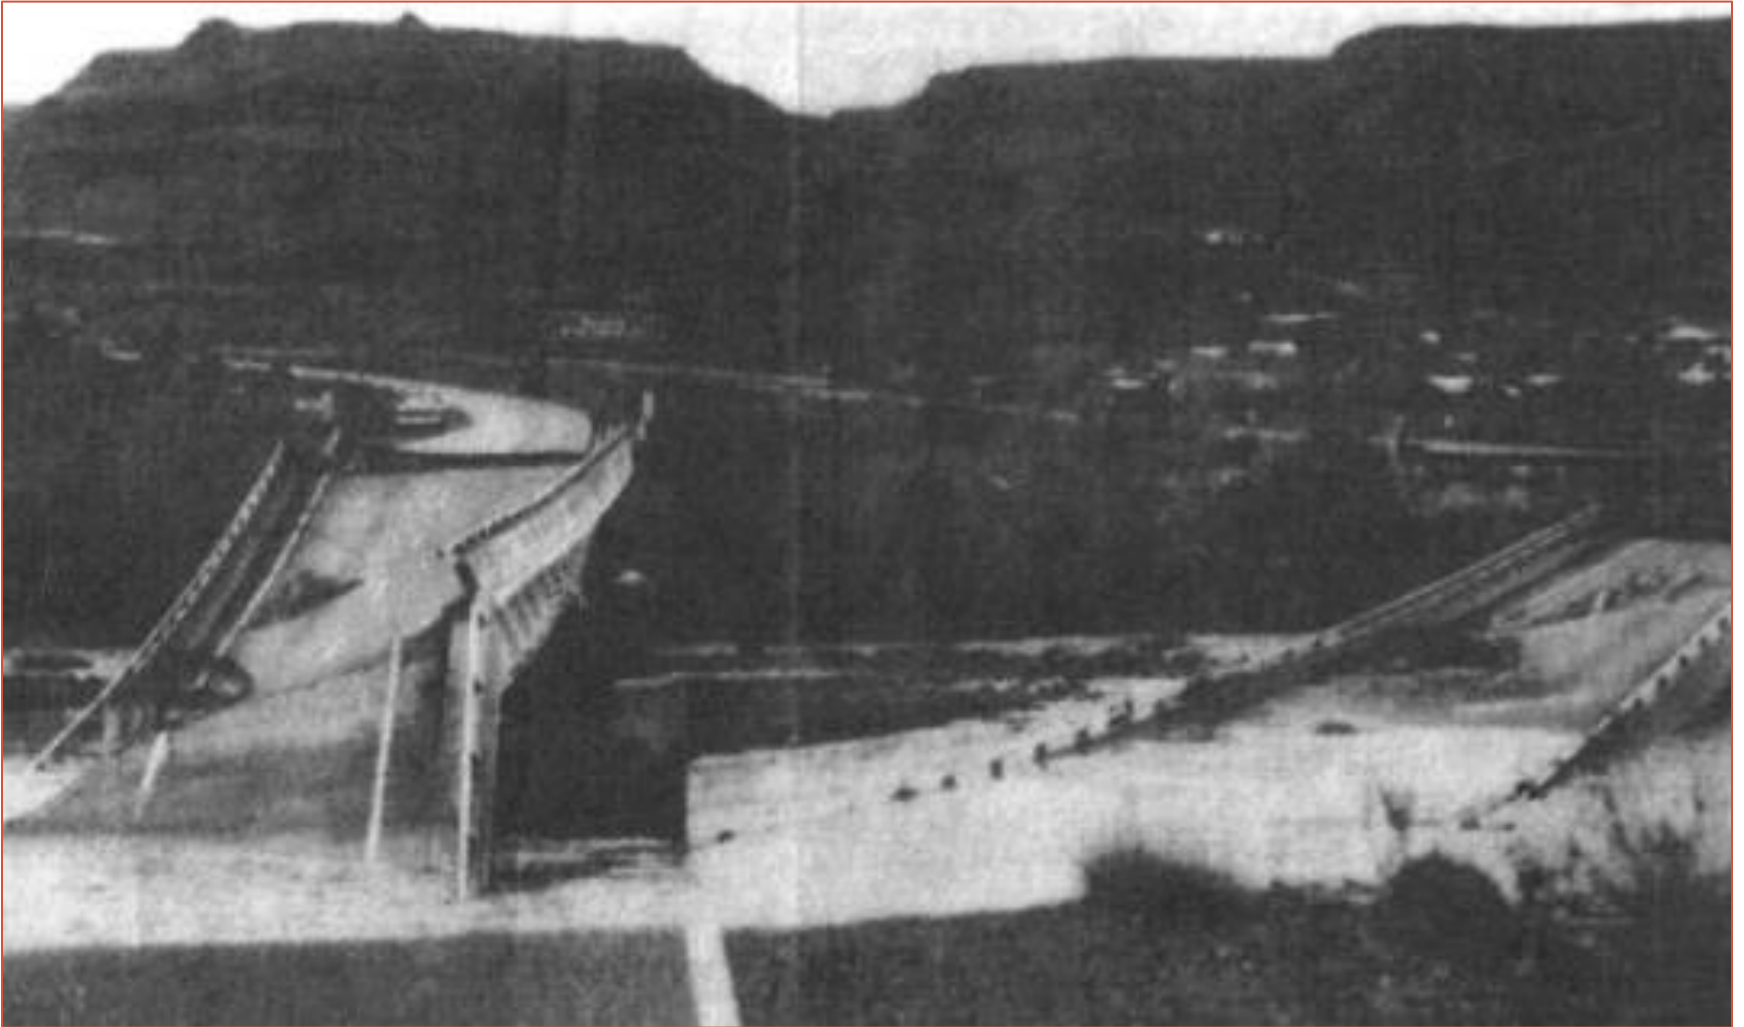
I-17 Bridge over Agua Fria River (Black Canyon City). (1960-1978)

Six people dead as result of bridge failure

- ❖ Design flow 37,000 cfs; actual flow 60,000 cfs
- ❖ Rail bank protection failed
- ❖ Spread footing on conglomerate material

- ❖ Footing needs to bear on bed rock

- ❖ Deep drilled shaft foundations

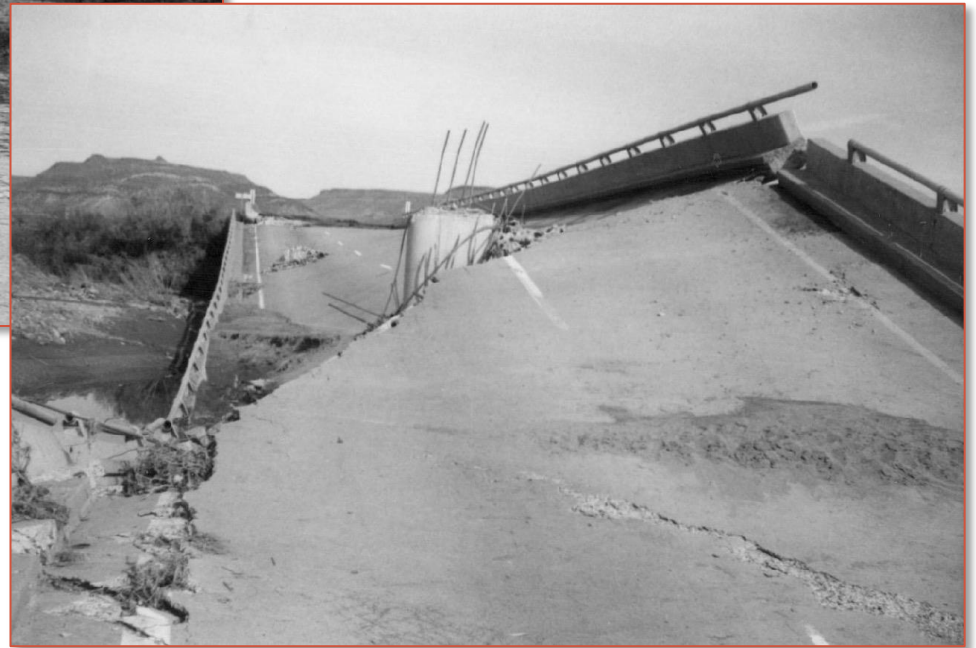
I-17 Bridge over Aqua Fria River

Abutment Failure –
footing on conglomerate

Collapsed Bridge - 1978

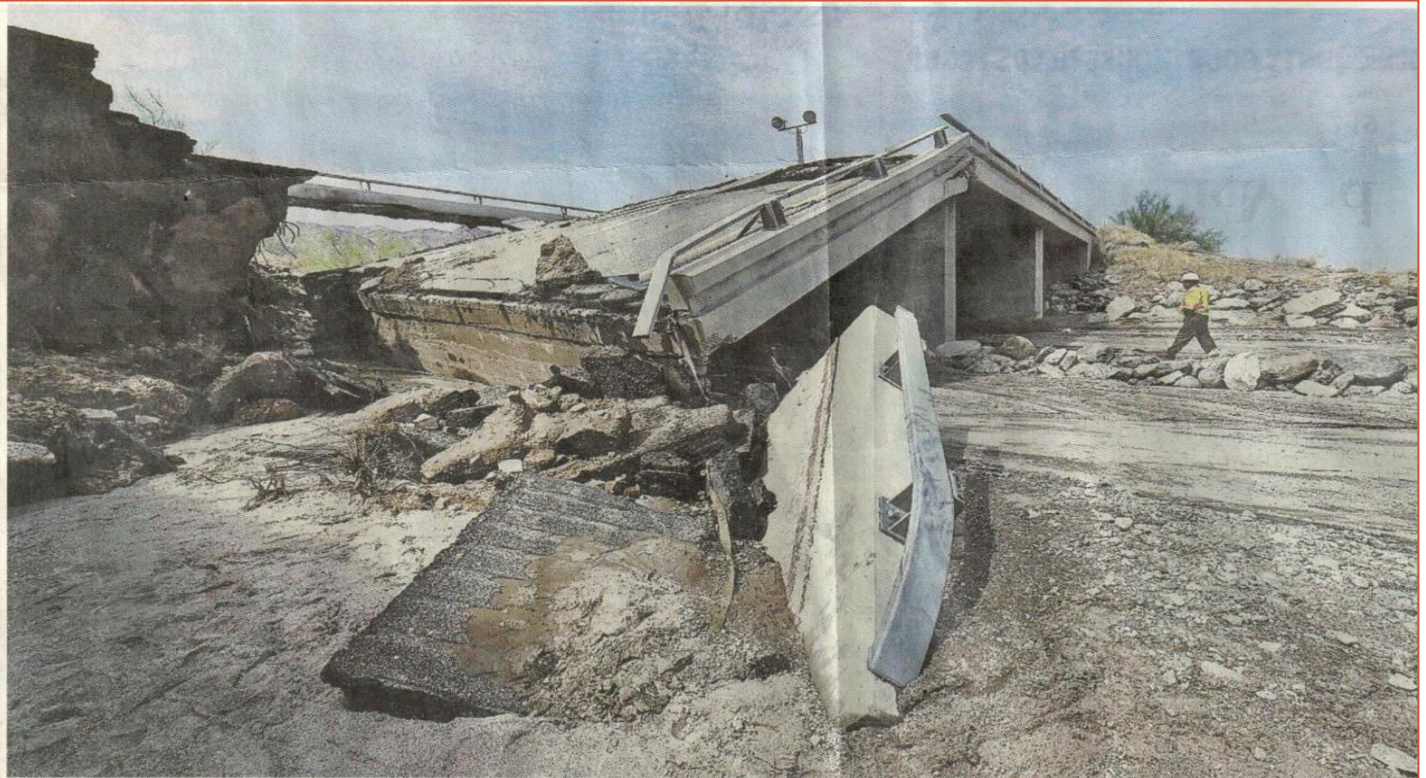
I-10 Bridge over Wash - 2015

An eastbound portion of the washed-out Interstate 10 bridge lies in the wash it once spanned after a flash flood undermined it on Saturday.
