2016 ANNUAL ASCE / ASHE STATE CONFERENCE

The High & Low of Engineering Options

Jerry A. Cannon, P.E., S.E.
Bridge Engineer

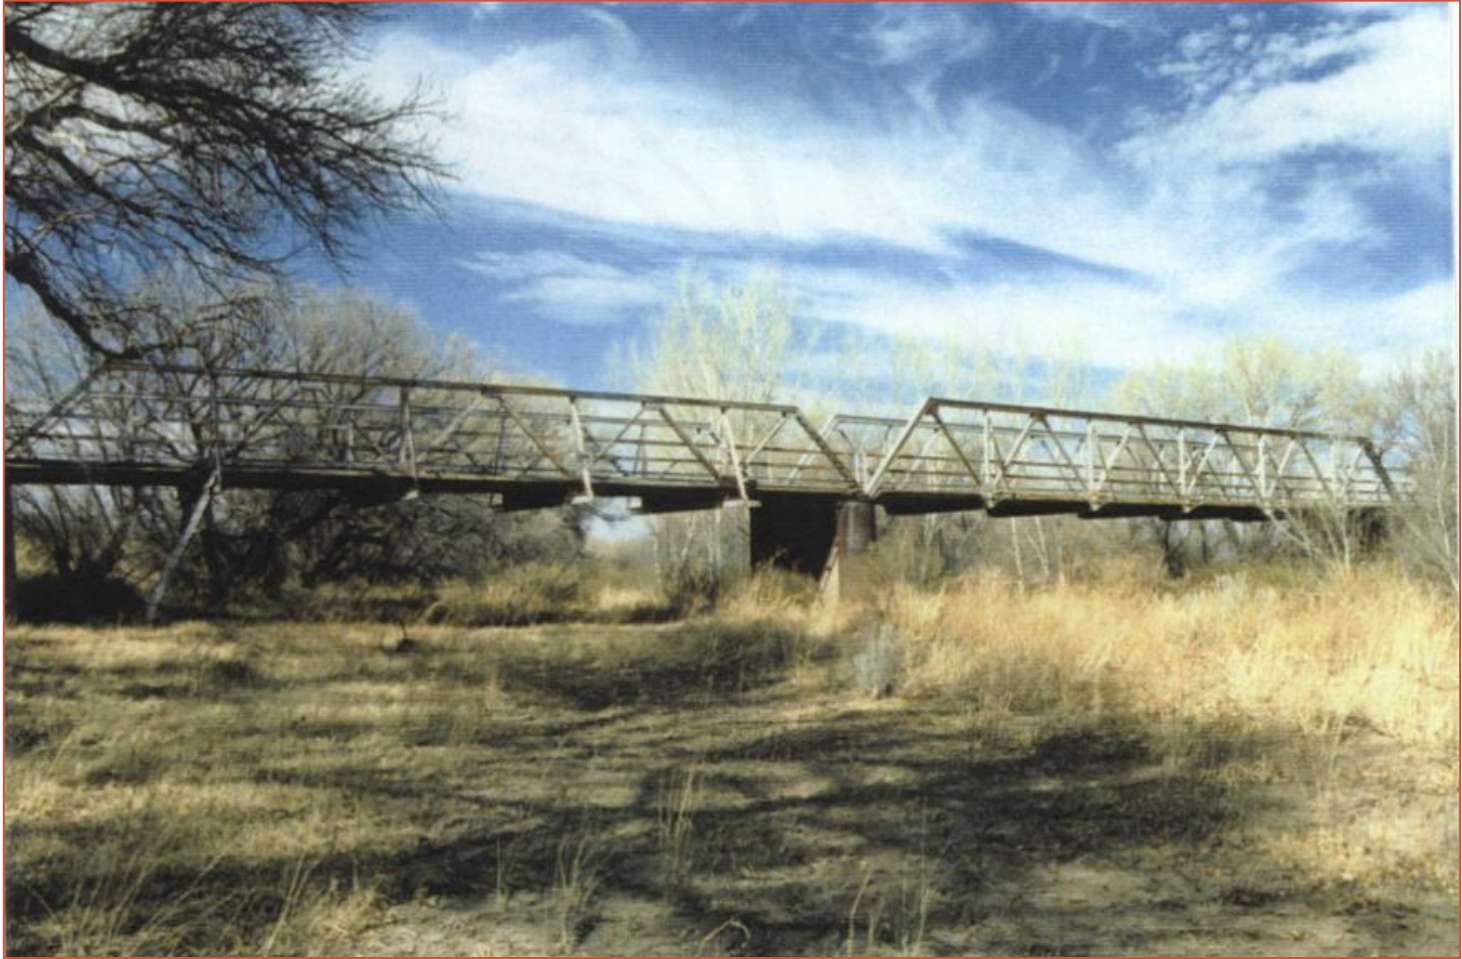
Historic Hereford Road Bridge over San Pedro River (1913, 1915, 1927)

Historic 3-span pony truss bridge posted for 15 ton live load

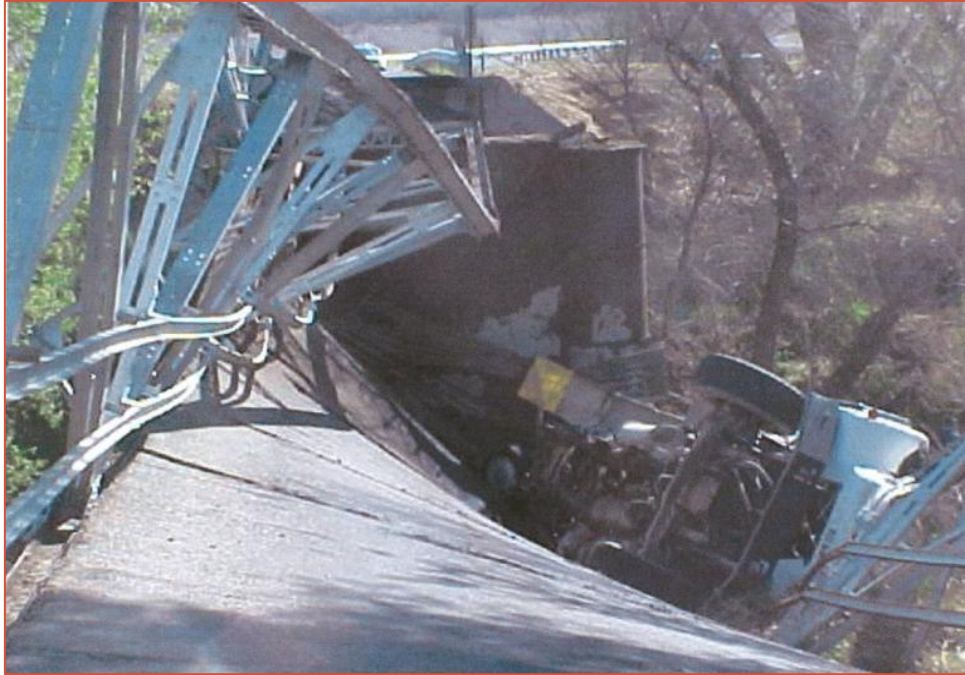
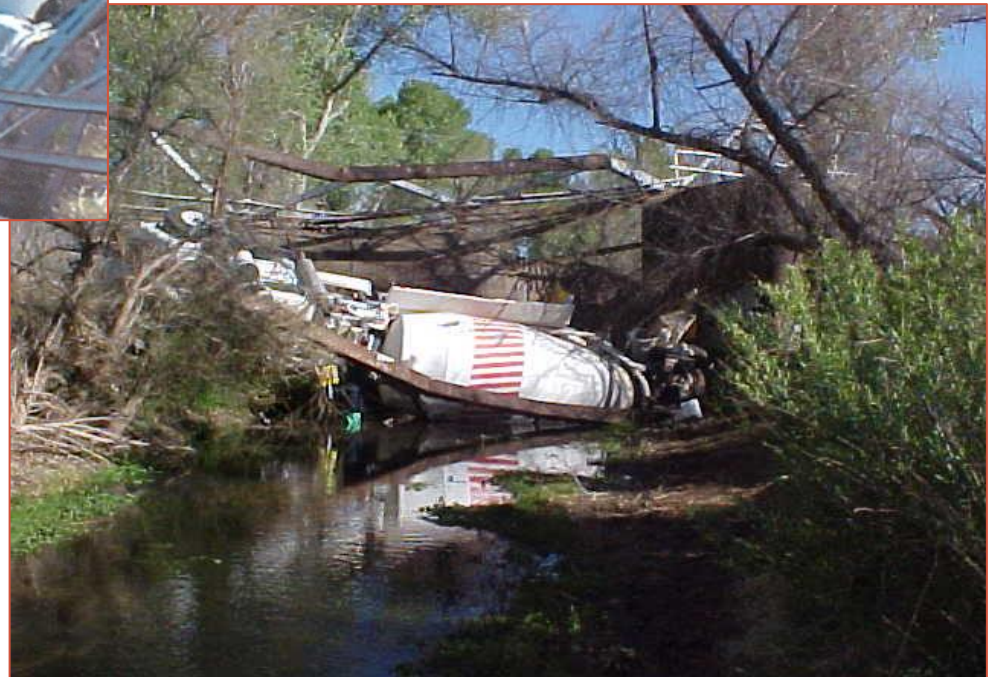
Historic Hereford Road Bridge Failure

Bridge posted for 15 tons.
April 2013 – 32 ton truck
collapsed bridge

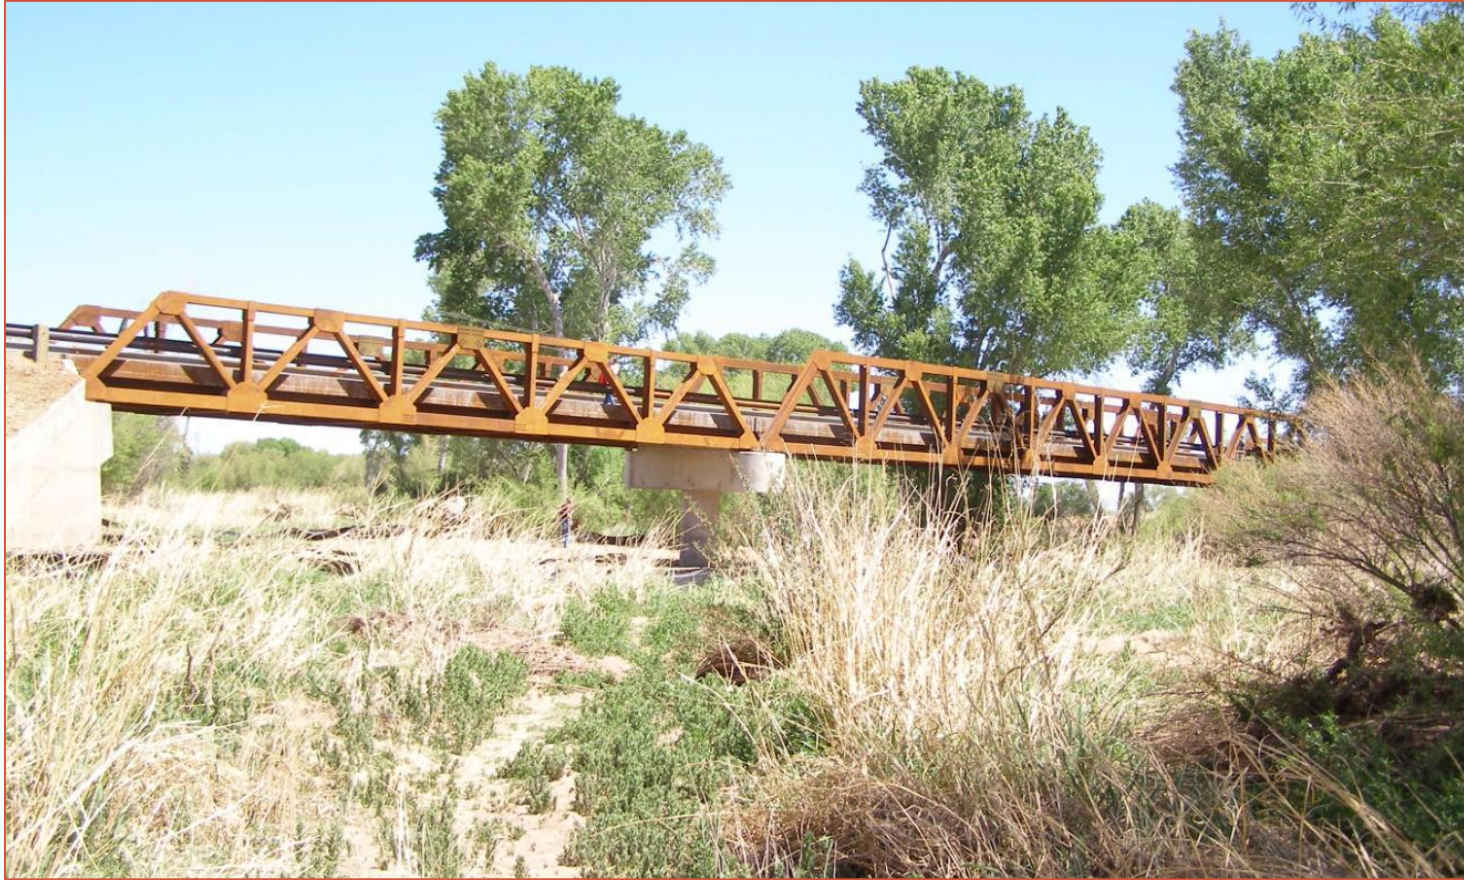
New Hereford Road Bridge

New three span, 1 lane, steel truss bridge dedicated March 6, 2006.

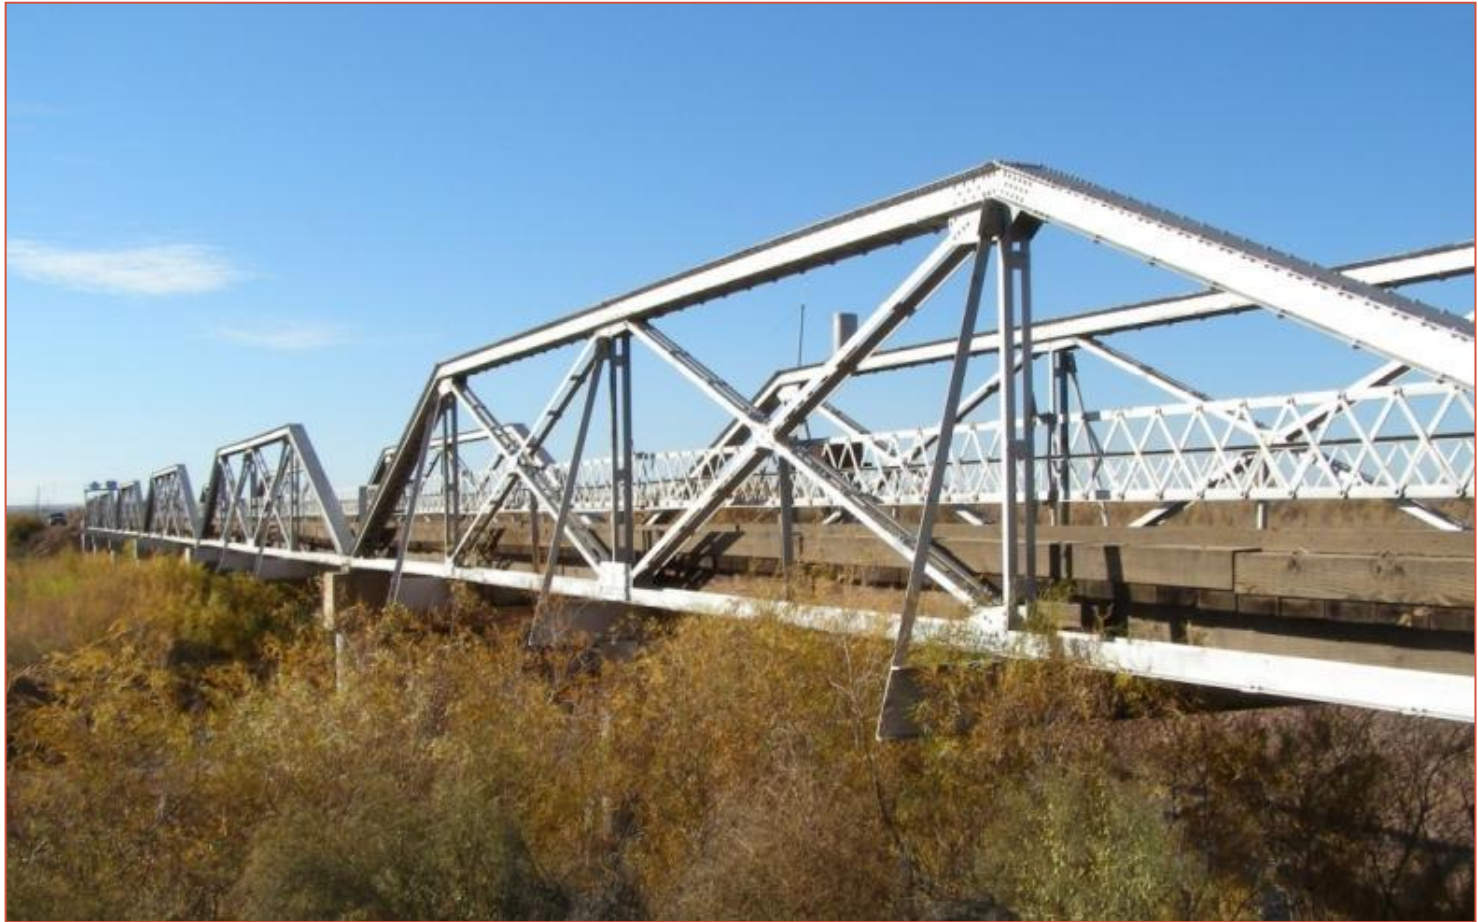
Historic Obed Road Bridge over Little Colorado River (1917)

Historic 6 span pony truss bridge – posted for 8 ton live load

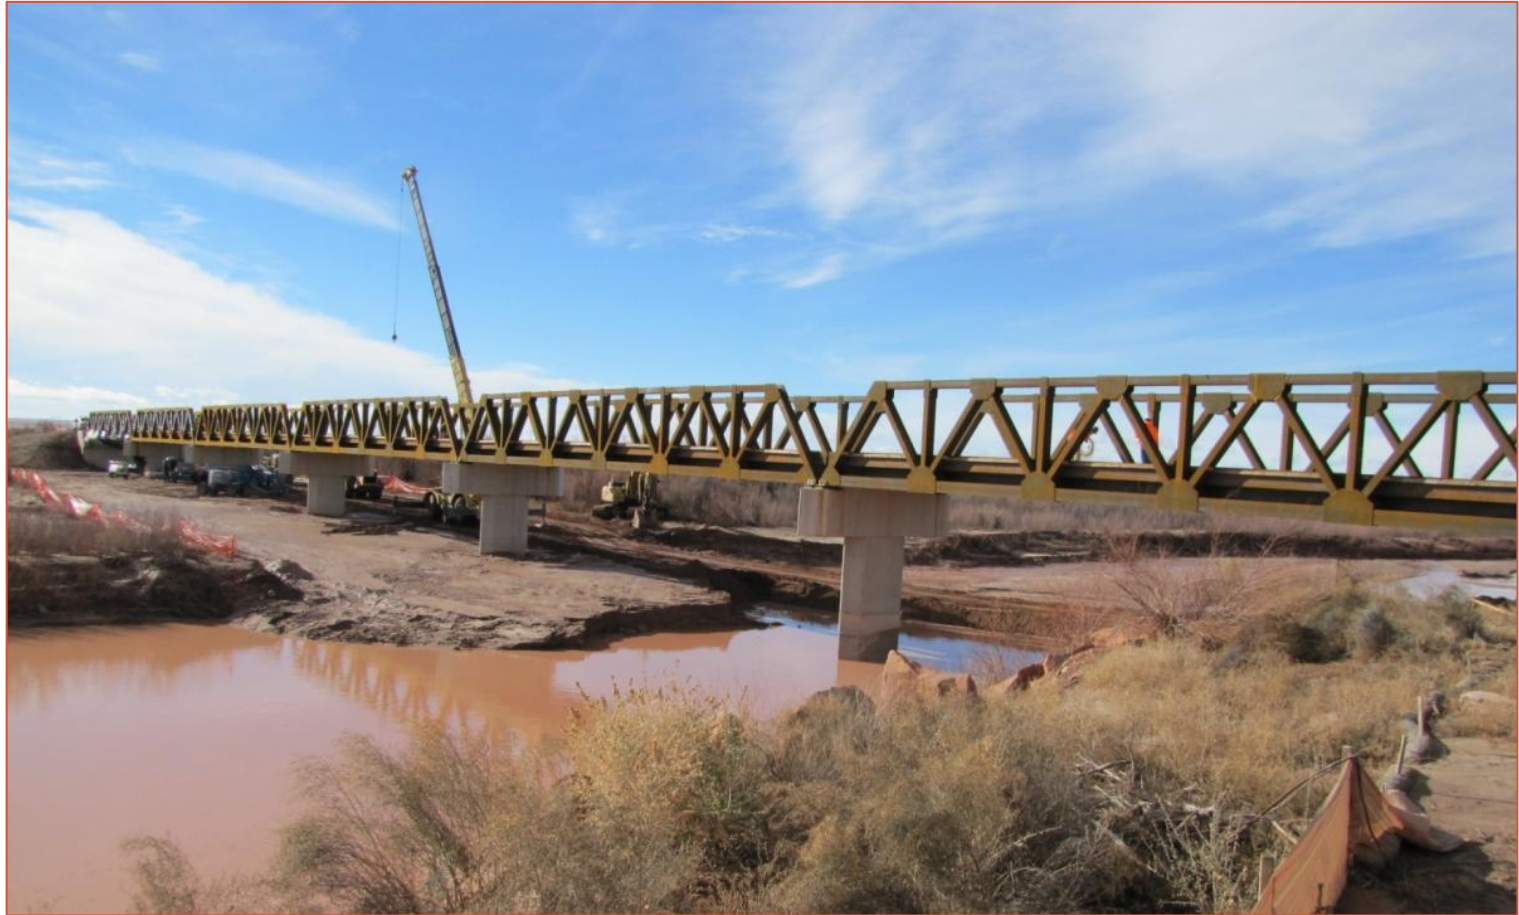
New Obed Road Bridge Replacement (2011)

New 6 span, one lane steel truss bridge dedicated 2011.

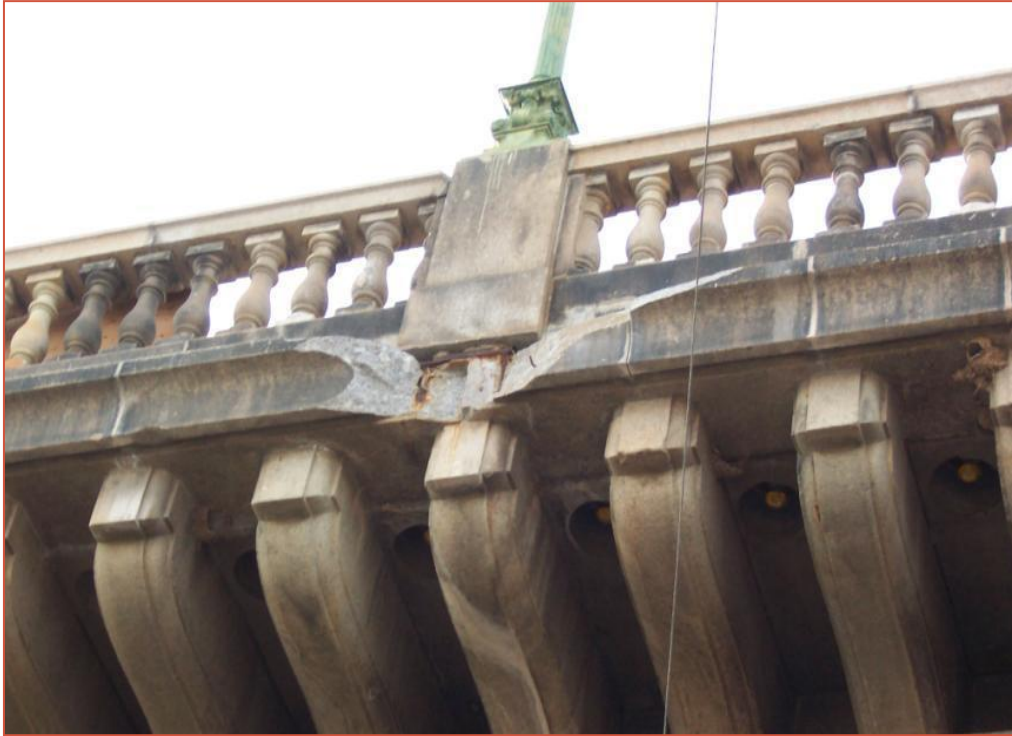
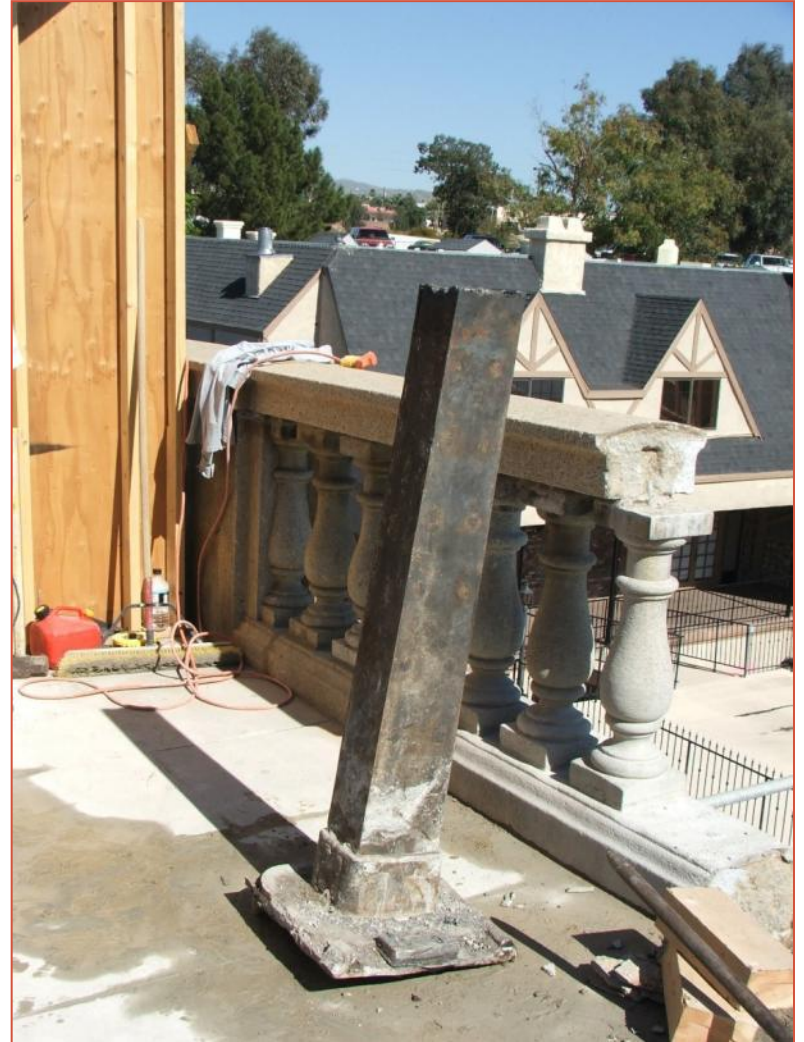
Historic London Bridge Lamp Post Repairs

Coping stone cracking at each lamp post

Cause of problem – removed rusted lamp support post

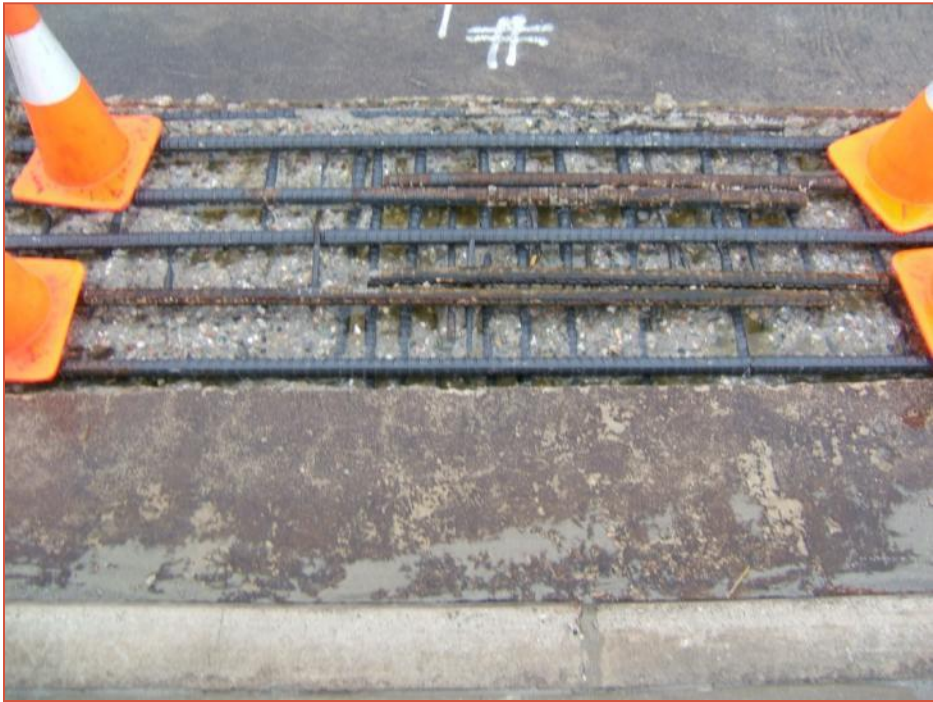
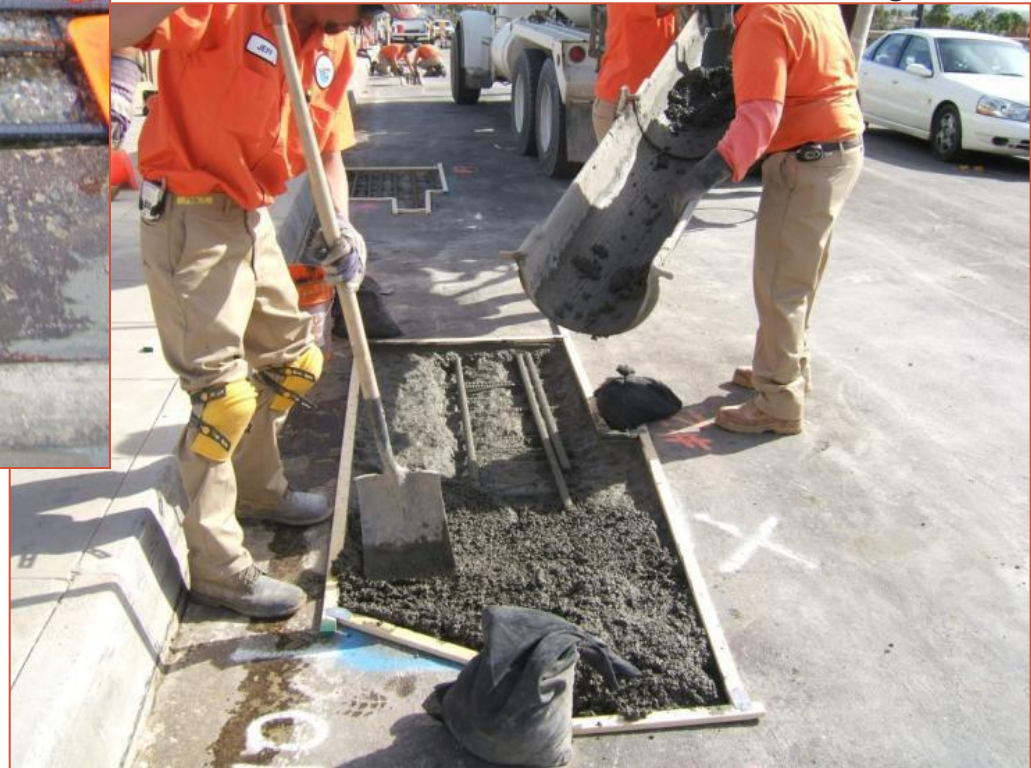
Historic London Bridge Lamp Post Repairs

Removal of deteriorated concrete

Forming edges and placement of
microsilica concrete to protect
reinforcing steel

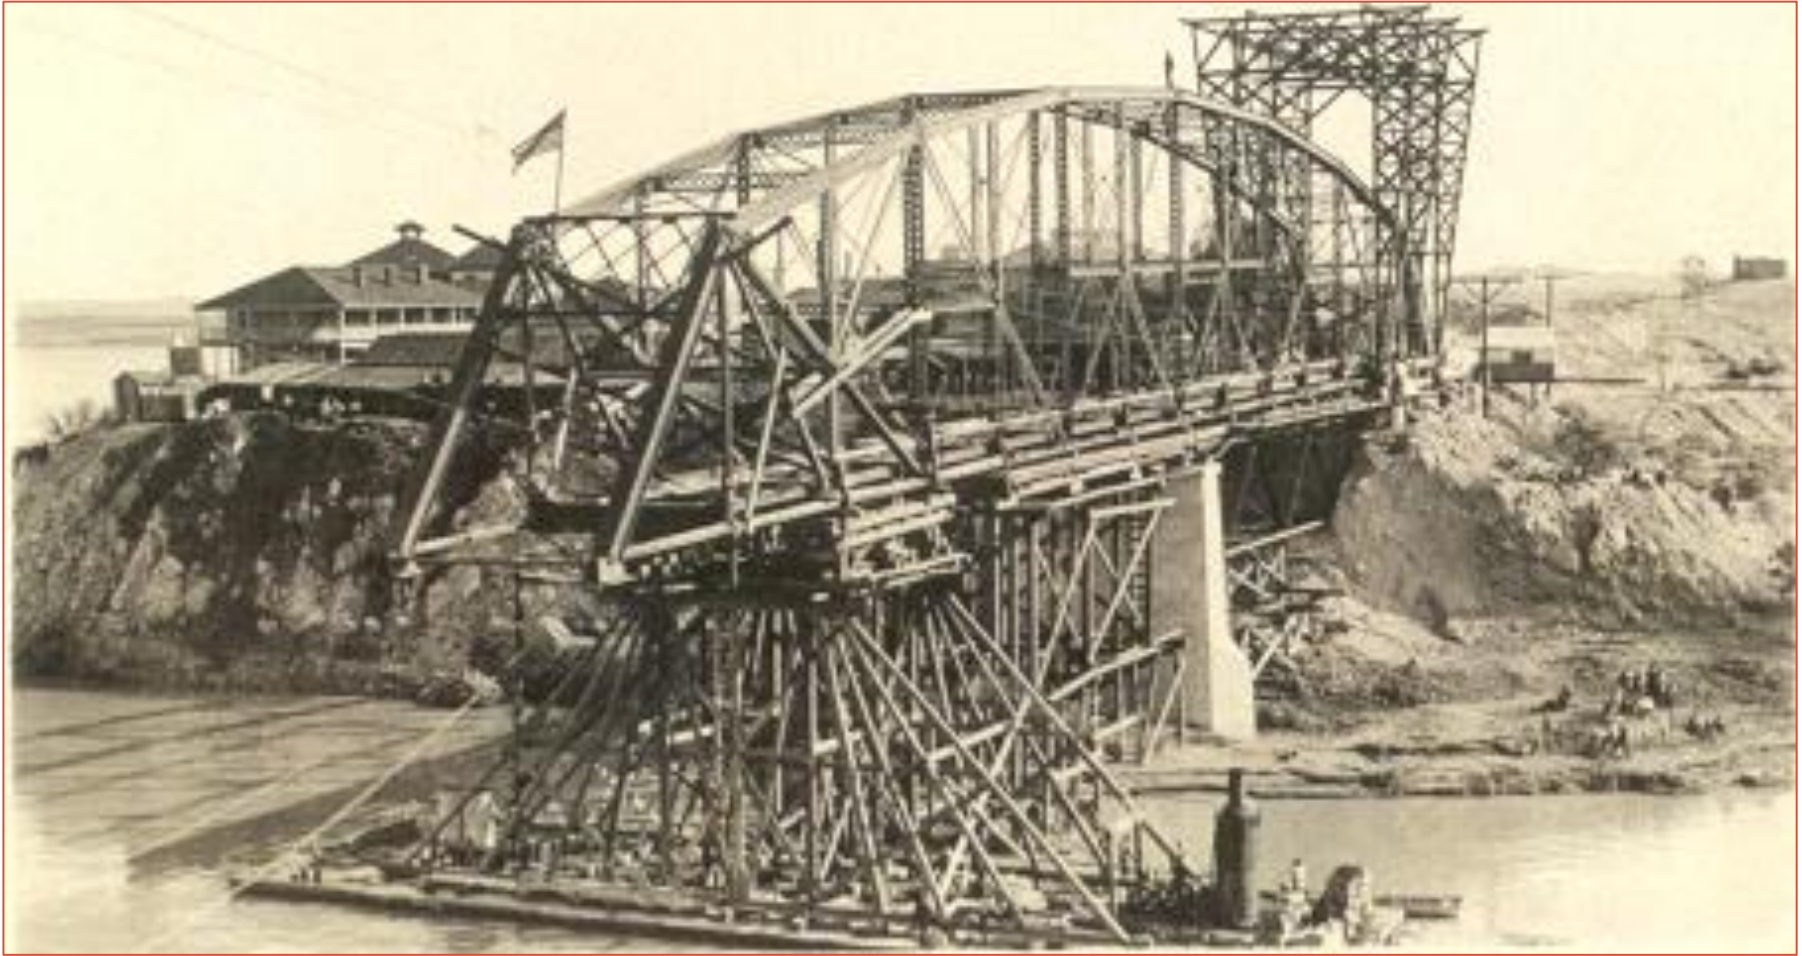
Historic Ocean-to-Ocean Highway Bridge

Bridge during construction in 1914

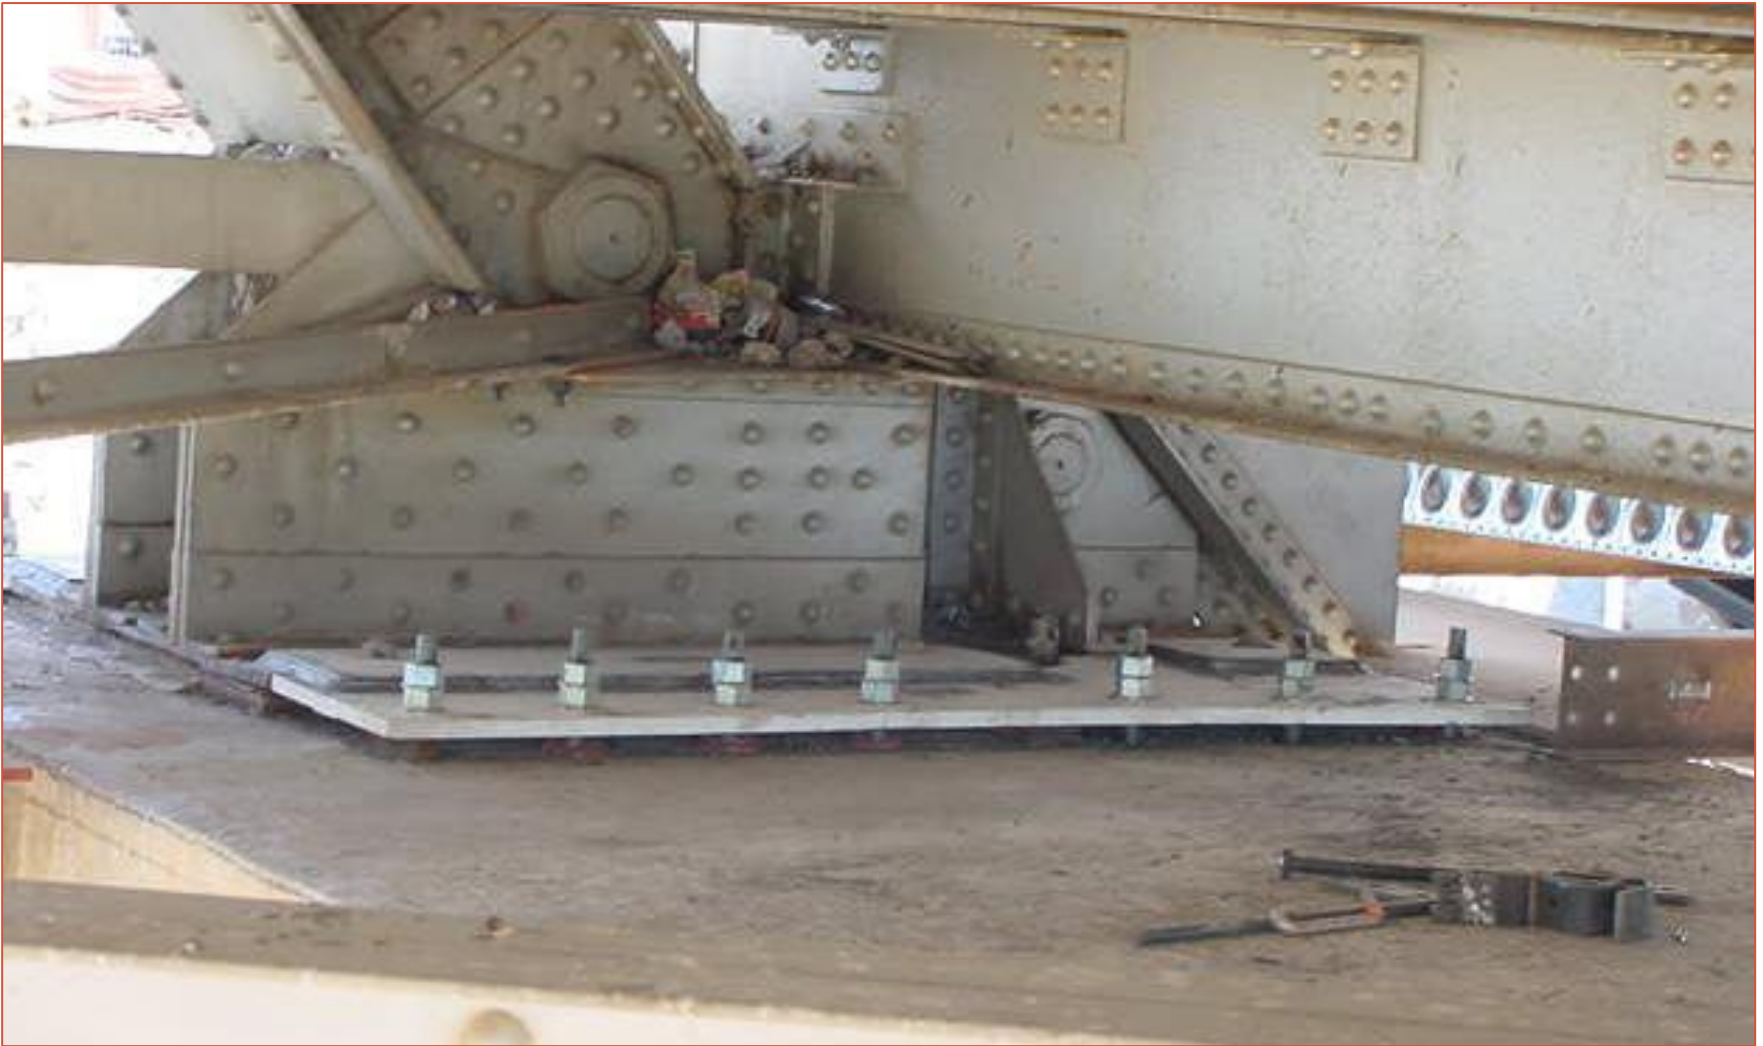
Historic Ocean-to-Ocean Highway Bridge Rehab

Steel truss attachment to pier wall

- Existing bolts rusted or missing – added new bolts

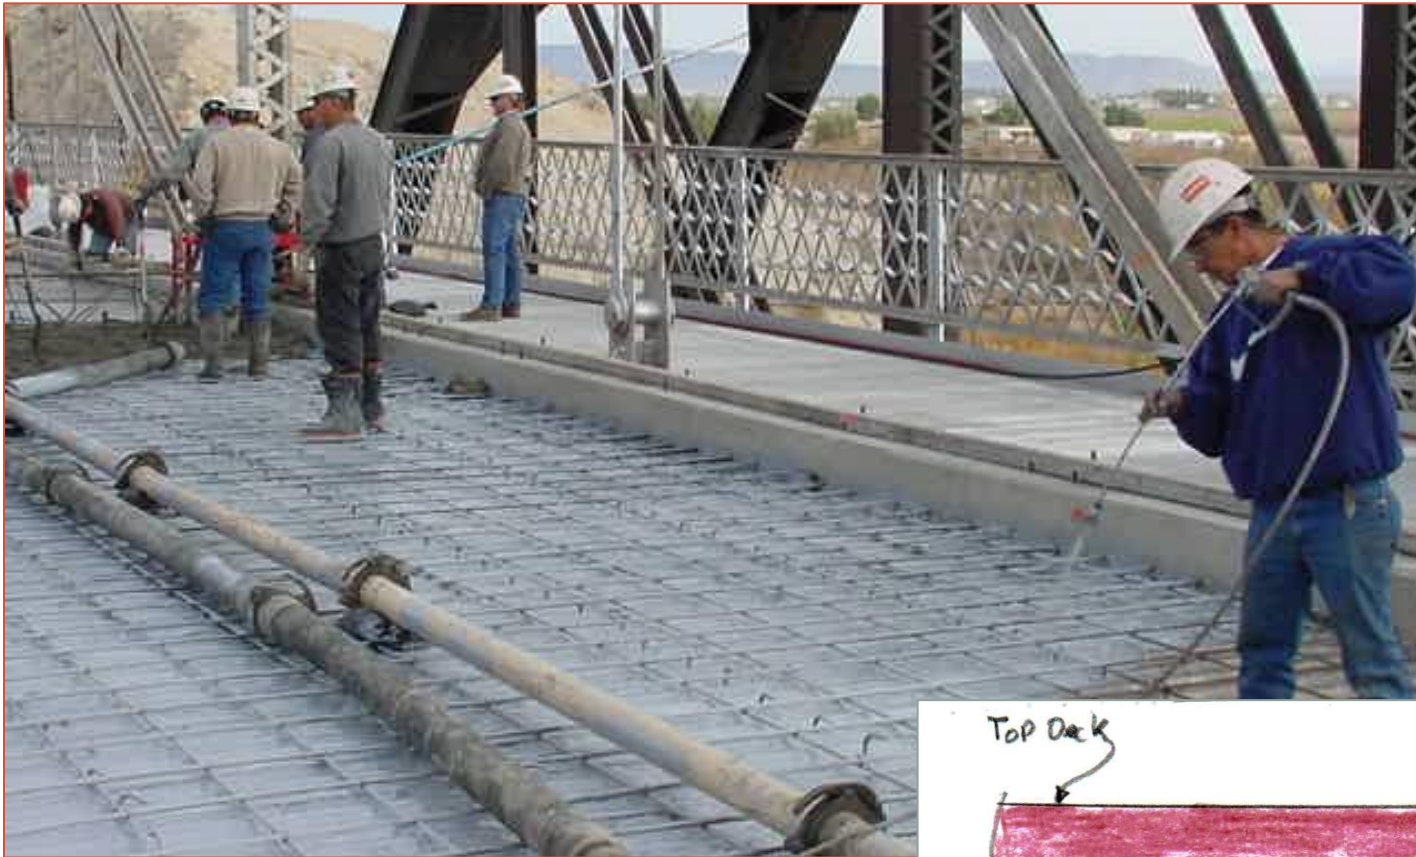
Historic Ocean-to-Ocean Highway Bridge Rehab

Bridge Deck Repair – existing asphalt topping replaced with concrete topping slab to prevent rusting of steel rail

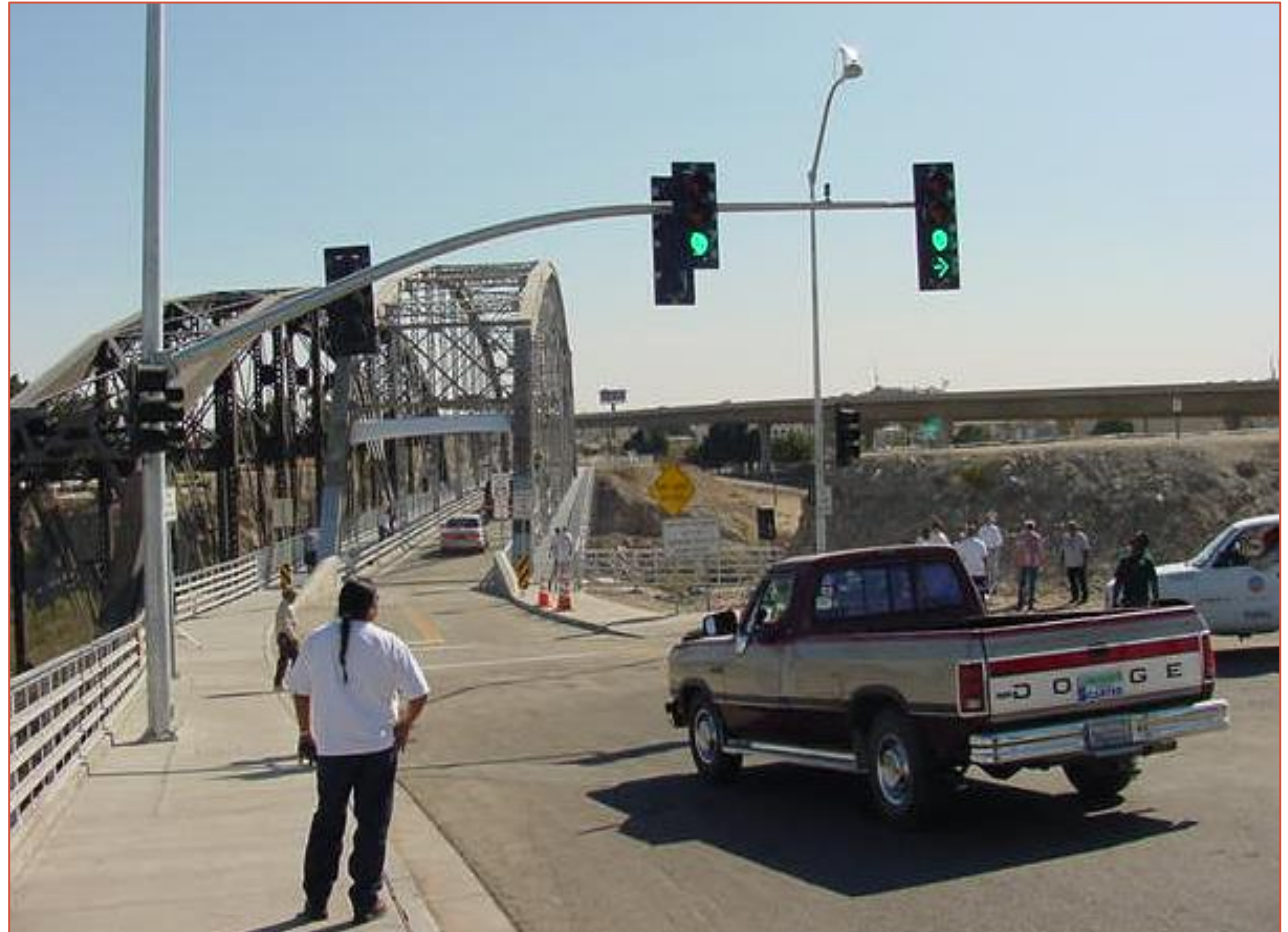
Historic Ocean-to-Ocean Highway Bridge – 1915 Railroad Bridge – Southern Pacific Railroad – 1923

- ❖ Vehicles travel one-way over bridge
- ❖ Video cameras installed to detect traffic; all signal flash red if vehicle stops on bridge

- ❖ Visit site before designing bridge
- ❖ Try and save as much of existing bridge as possible
- ❖ Innovative approach to traffic control

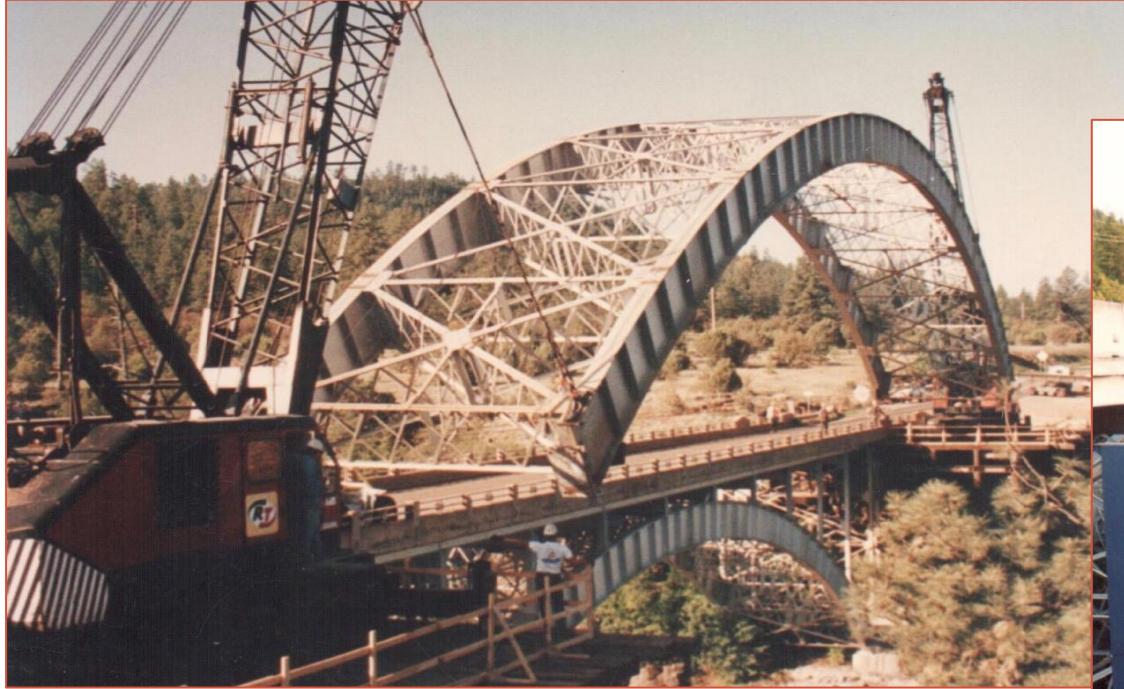
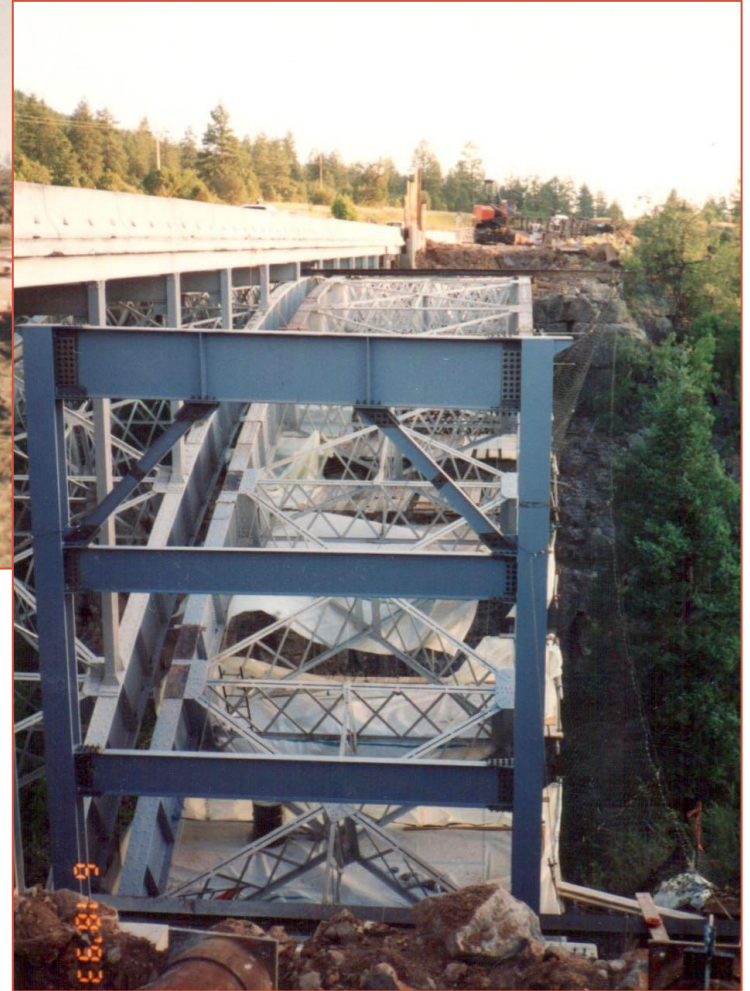
Historic US60 Cedar Canyon Bridge Widened

Crane unloading steel arches from Corduroy Creek Bridge

Corduroy Creek arches set in place to widen Cedar Canyon Bridge

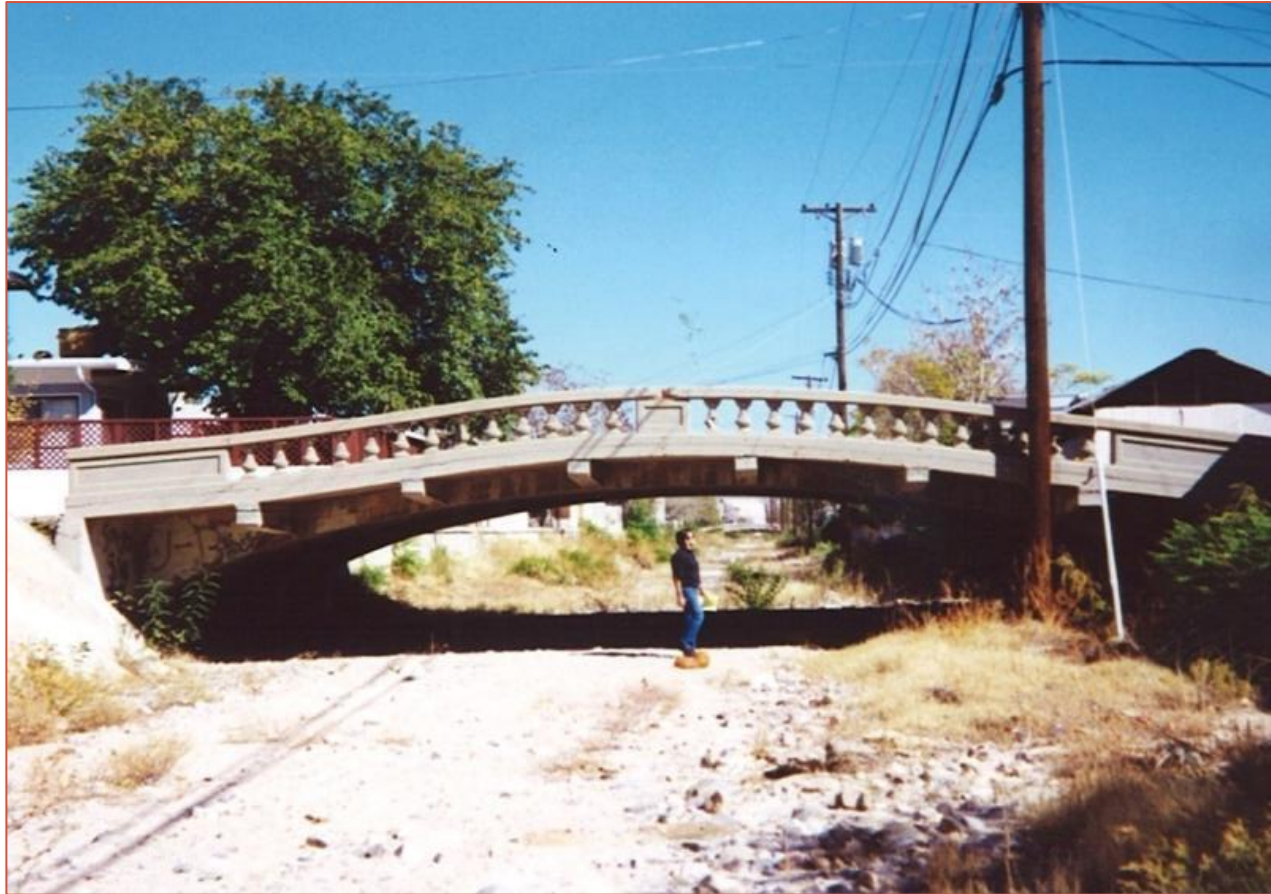
One of 5 identical bridges that span Bloody Tanks Wash

- ❖ Historic bridges rehabilitated; making use of existing cultural resources
- ❖ Bridge rehabilitation saved money rather than replacing the bridge

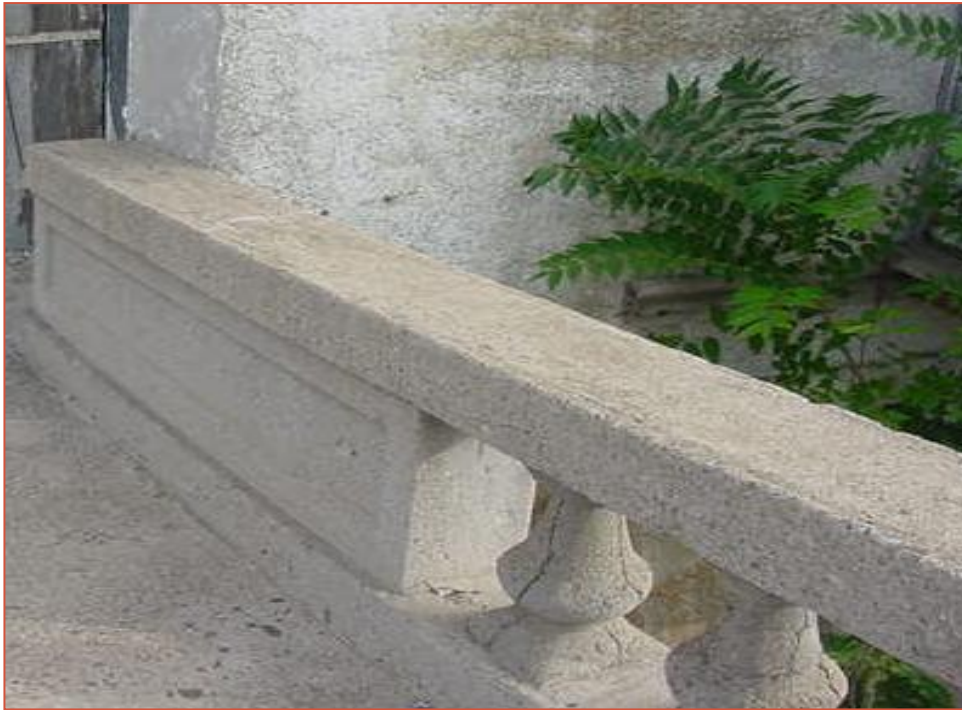
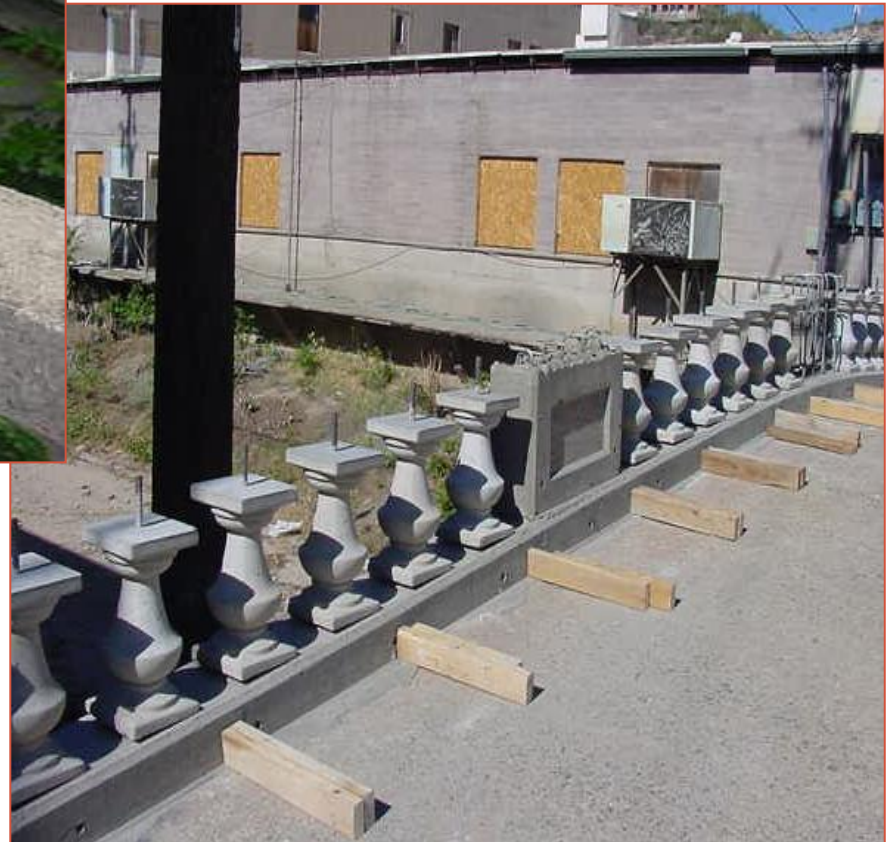
Historic Bloody Tanks Wash Bridges

Deteriorated barrier
rail in need of repair

Replaced barrier rail with near
replica of historic railing

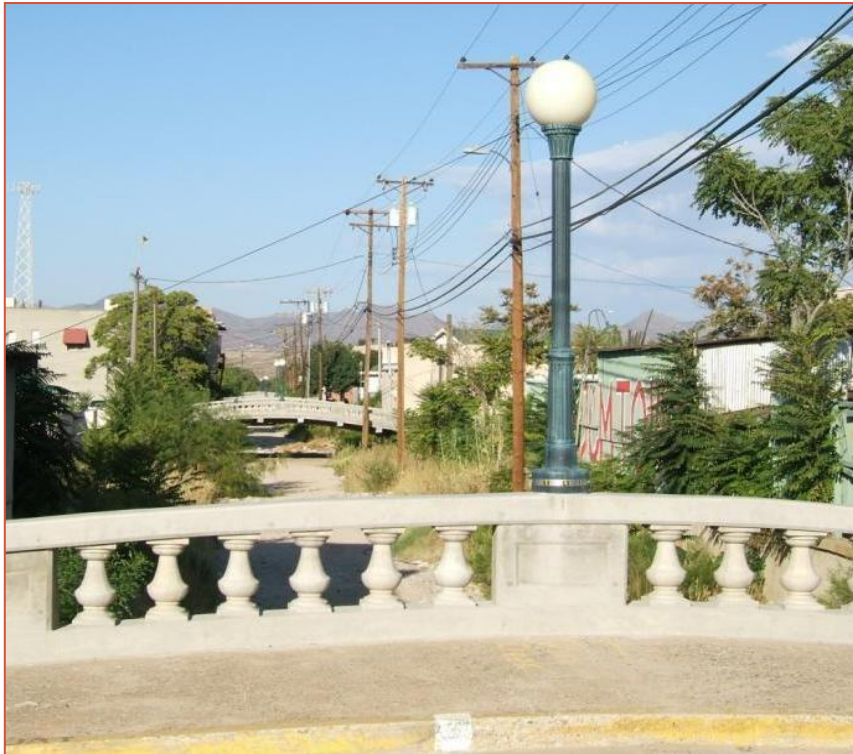
Historic Bloody Tanks Wash Bridges

New bridge barrier rail with decorative lights

Luten Arch Bridge – Cambered
Bridge: posted speed / no trucks
